Our Reference: 32564

**Reference: Sewer Fixture & Fittings Corrosion – Observations and Recommendations**

Our Reference: 32683

**Reference: Water Fixture & Fittings Corrosion – Observations and Recommendations**

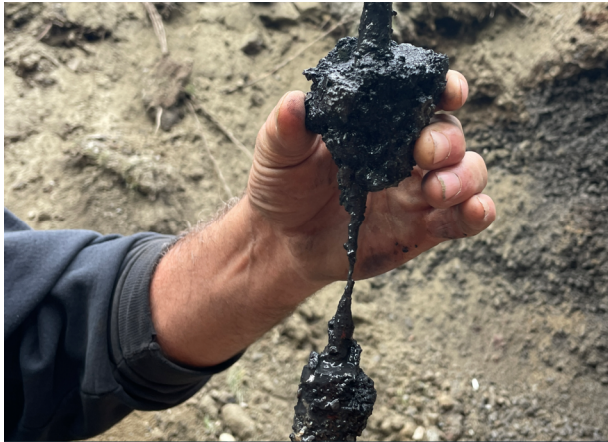
Upon completion of all sanitary sewer valve and fitting replacements, it can be confirmed that corrosion was present in all instances; however, the degree of corrosive attack varied. In general, the corrosion was the most extreme on the restraining rings and rods (to the point of near failure in some instances).

Photo 1 - Corroded Restraining Rod.

After review of our observations and findings it appears that corrosion was the worst in cases where there was heavy groundwater present in the trench. It was also noted that the restraining rings and rods were most subject to corrosive attack. Valves and the fittings themselves complete with hardware appeared to be less affected however corrosion was observed on these items and if left in place future failure of these fittings is considered likely.

- Continue with fittings replacement program focusing on areas where there have been recent failures and/or areas that extensive corrosion has been noted during excavation.
- Scheduled replacement will likely be more cost effective and less disruptive in comparison with emergency replacement in the unfortunate case of failure.
- When replacing any iron works wrapping in Denso as per manufacturers specifications with the three-part system is imperative.
- Look into other methods of corrosion control available.

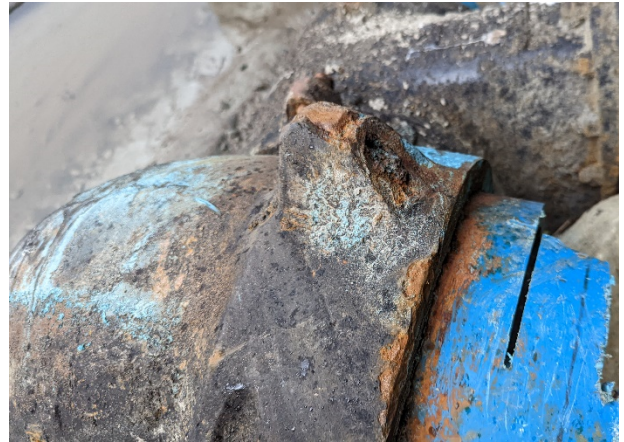
Photo 2 - Corroded 90° Bend Restraining Ear.

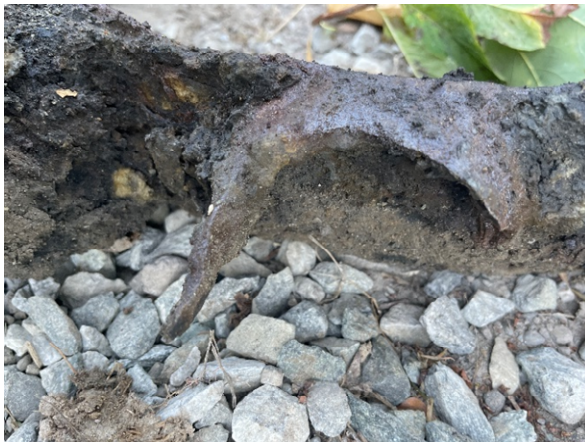
Photo 3 - Corroded Restraining Ring Ear.

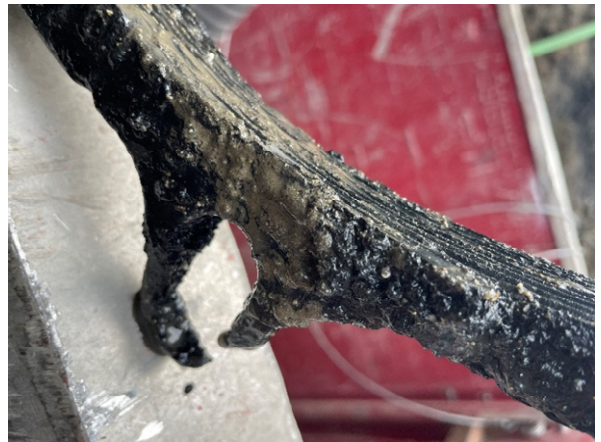
Photo 4 - Corroded Restraining Ring Ear.

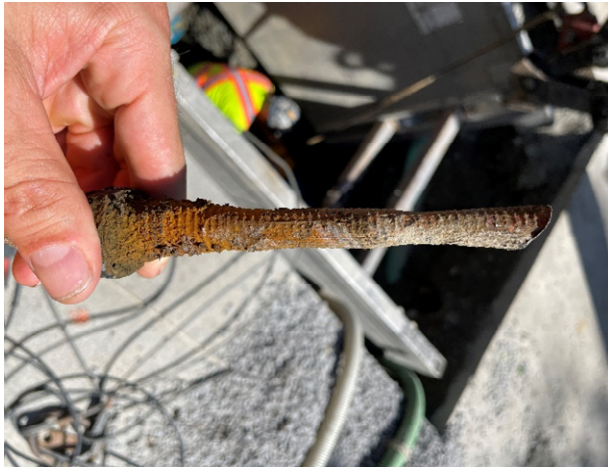
Upon completion of all water valve/fitting replacements, it can be confirmed that corrosion was present in all instances; however, the degree of corrosive attack varied. As Drake moved north on Northlands Boulevard the corrosion worsened. In general, the corrosion was the most extreme on the restraining rings and rods.

Photo 1 - Corroded Restraining Rod.

After review of our observations/findings it appears that corrosion was the worst in cases where there was heavy groundwater present in the trench. It was also noted that the restraining rings and rods were most subject to corrosive attack. Valves and the fittings themselves complete with hardware appeared to be less affected however corrosion was observed on these items and if left in place future failure of these fittings is considered likely.

- Continue with fittings replacement program focusing on areas where there have been recent failures and/or areas that extensive corrosion has been noted during excavation.
- Scheduled replacement will likely be more cost effective and less disruptive in comparison with emergency replacement in the unfortunate case of failure.
- When replacing any iron works wrapping in Denso as per manufacturers specifications with the three-part system is imperative.
- Look into other methods of corrosion control available.

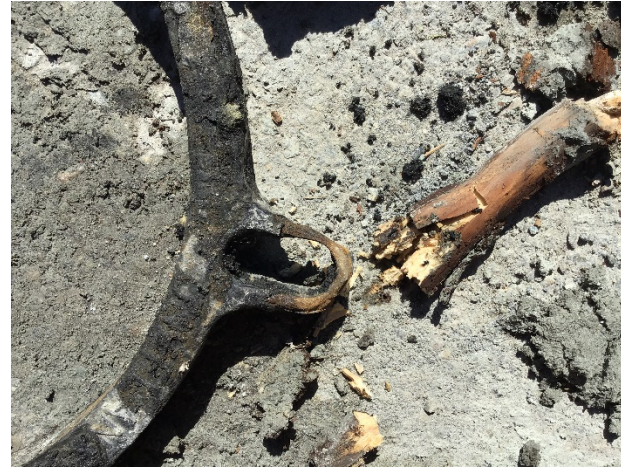
Photo 2 - Corroded Restraining Ring Ear.

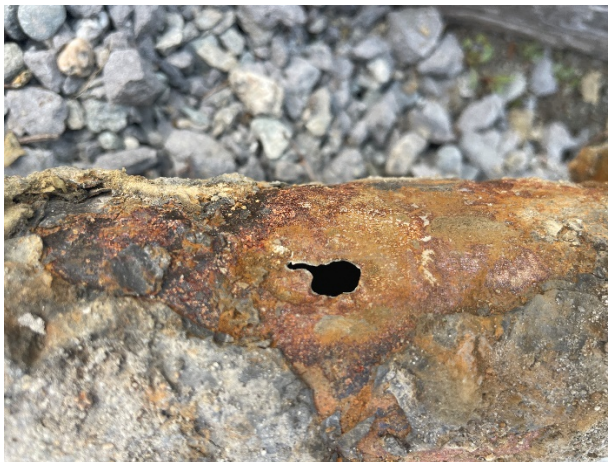
Photo 3 – Blow-off Pipe Corrosion.

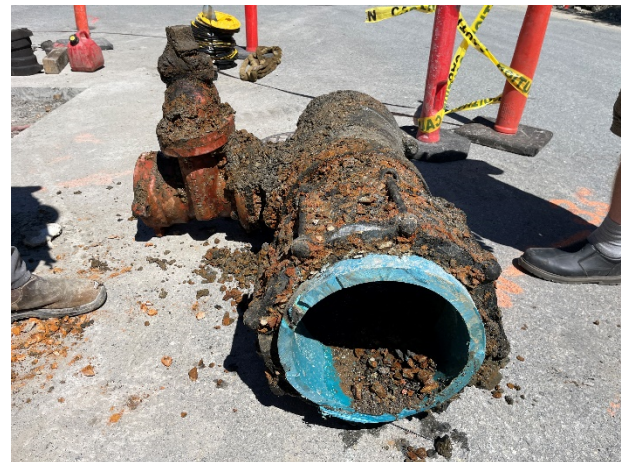
Photo 4 – Valve & Tee Corrosion.
