January 13, 2023

Resort Municipality of Whistler
4325 Blackcomb Way
Whistler, BC V8E 0X5

Reference: Sewer Fixture & Fittings Corrosion – Observations and Recommendations

Reference: Water Fixture & Fittings Corrosion – Observations and Recommendations

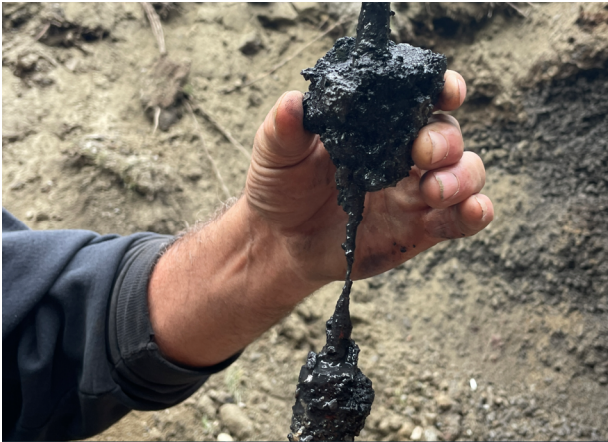
Upon completion of all sanitary sewer valve and fitting replacements, it can be confirmed that corrosion was present in all instances; however, the degree of corrosive attack varied. In general, the corrosion was the most extreme on the restraining rings and rods (to the point of near failure in some instances).

Photo 1 - Corroded Restraining Rod.

- Continue with fittings replacement program focusing on areas where there have been recent failures and/or areas that extensive corrosion has been noted during excavation.
- Scheduled replacement will likely be more cost effective and less disruptive in comparison with emergency replacement in the unfortunate case of failure.
- When replacing any iron works wrapping in Denso as per manufacturers specifications with the three-part system is imperative.
- Look into other methods of corrosion control available.

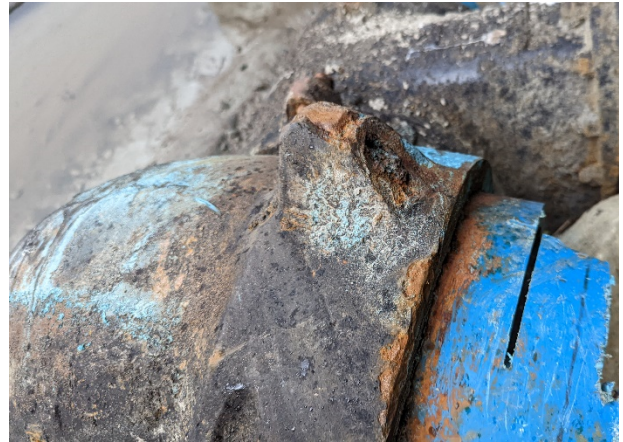
Photo 2 - Corroded 90° Bend Restraining Ear.

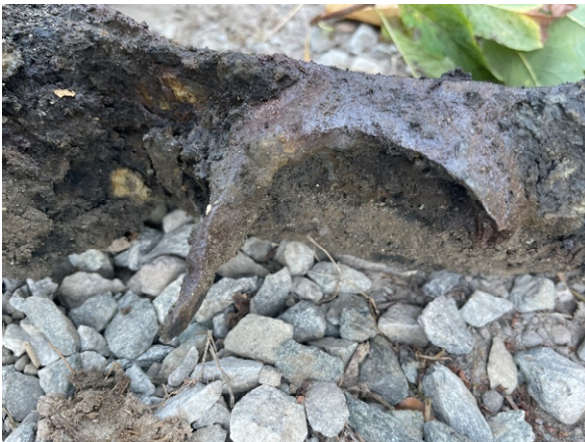
Photo 3 - Corroded Restraining Ring Ear.

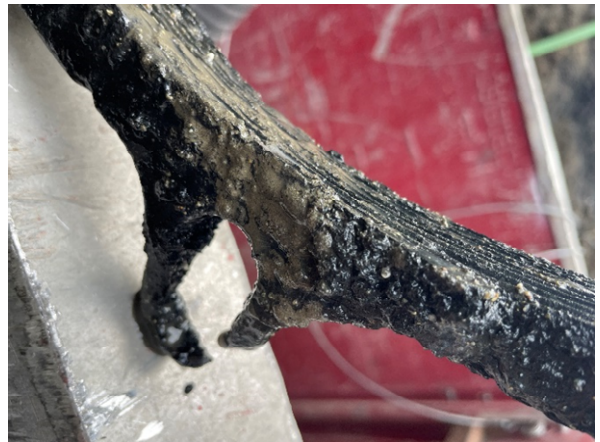
Photo 4 - Corroded Restraining Ring Ear.

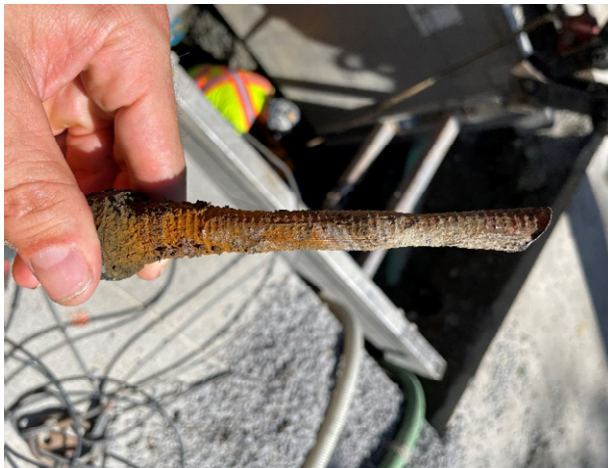
Upon completion of all water valve/fitting replacements, it can be confirmed that corrosion was present in all instances; however, the degree of corrosive attack varied. As Drake moved north on Northlands Boulevard the corrosion worsened. In general, the corrosion was the most extreme on the restraining rings and rods.

Photo 1 - Corroded Restraining Rod.

- Continue with fittings replacement program focusing on areas where there have been recent failures and/or areas that extensive corrosion has been noted during excavation.
- Scheduled replacement will likely be more cost effective and less disruptive in comparison with emergency replacement in the unfortunate case of failure.
- When replacing any iron works wrapping in Denso as per manufacturers specifications with the three-part system is imperative.
- Look into other methods of corrosion control available.

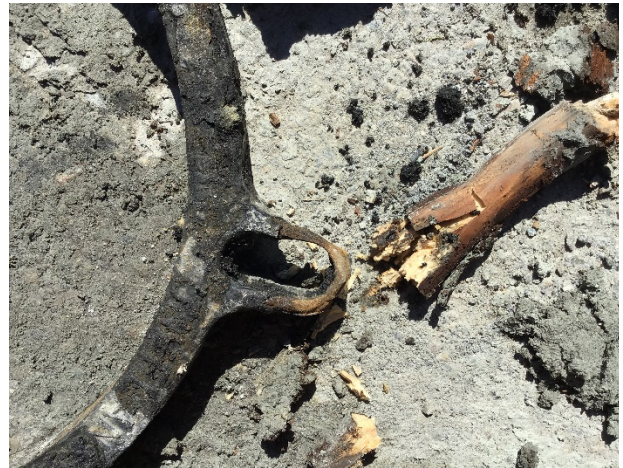
Photo 2 - Corroded Restraining Ring Ear.

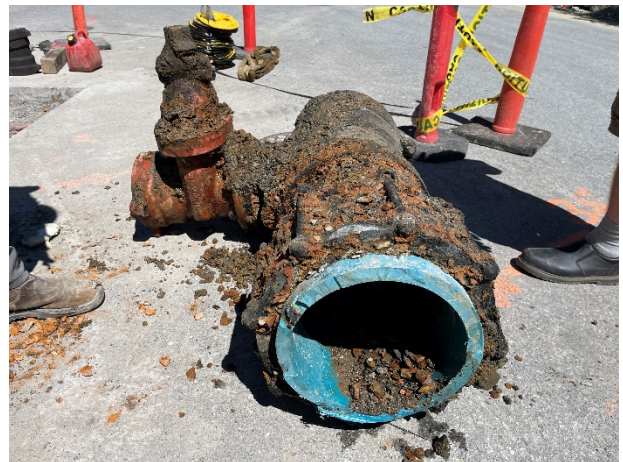
Photo 4 – Valve & Tee Corrosion.

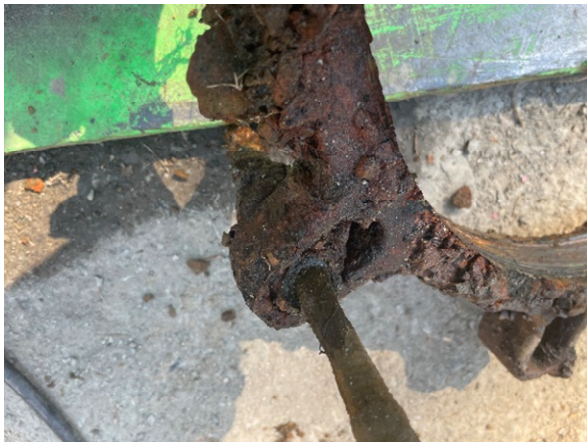
Photo 1 - Corroded Restraining Rod (S1-7 90° Bend)

Upon analysis of our observations, it has become evident that the fitting restraining rods were the primary target of corrosive degradation. The likelihood of future failure of these rods in certain instances is significant if left unaddressed. Fittings themselves and restraining rings appeared to have less severe corrosive degradation.

- Continue with fittings replacement program focusing on areas where there have been recent failures and/or areas that extensive corrosion has been noted during excavation.
- Scheduled replacement will likely be more cost effective and less disruptive in comparison with emergency replacement in the unfortunate case of failure.
- When replacing any iron works wrapping in Denso as per manufacturers specifications with the three-part system is imperative.
- Look into other methods of corrosion control available.

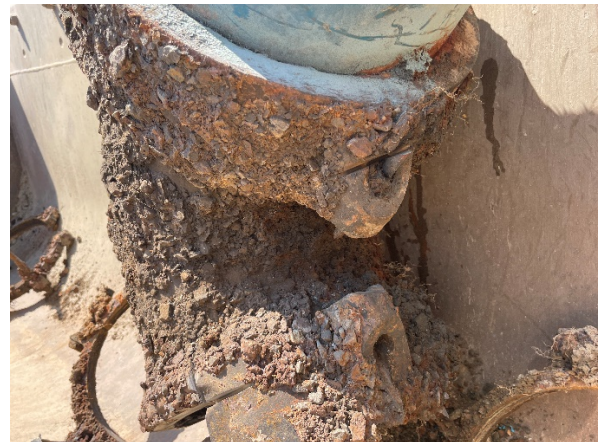
Photo 2 – Encrustation and Surface Corrosion (S1-7 90° Bend)

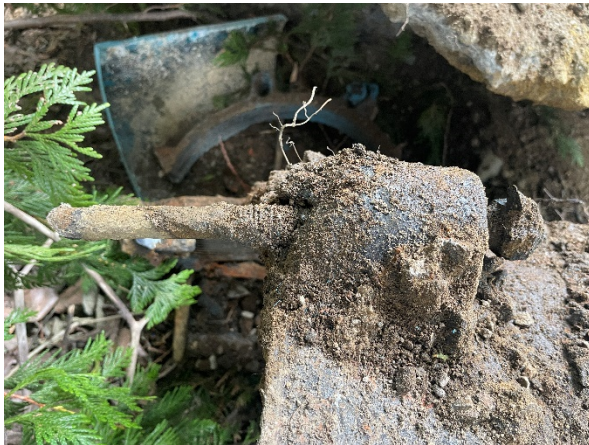
Photo 3 - Corroded Restraining Rod (S1-4 11.25° Bend)

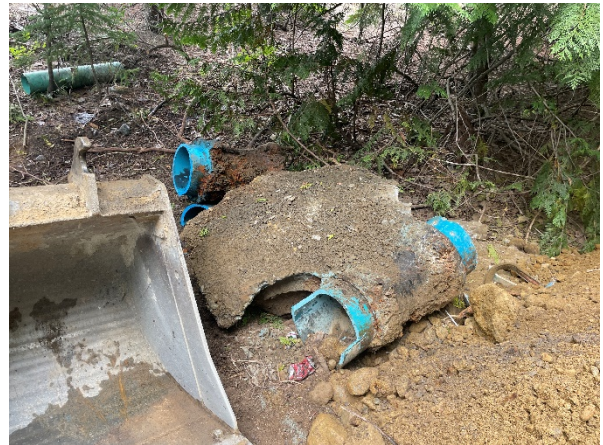
Photo 4 - Encrustation and Surface Corrosion (S1-6 11.25° Bend)

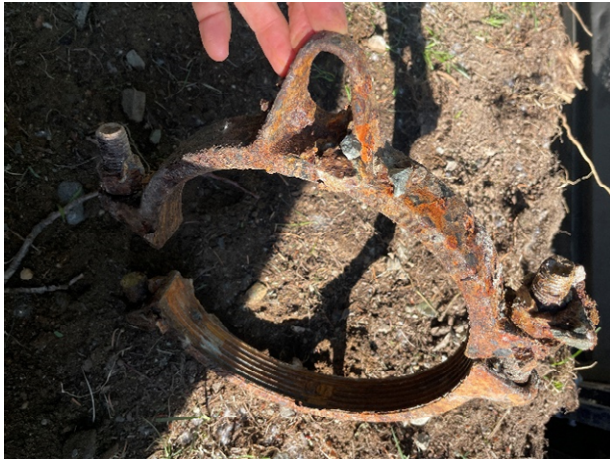
Photo 1 – Minor Surface Corrosion on Restraining Ring W1-17

- Continue with fittings replacement program focusing on areas where there have been recent failures and/or areas that extensive corrosion has been noted during excavation.
- When replacing any iron works wrapping in Denso as per manufacturers specifications with the three-part system is imperative.
- Look into other methods of corrosion control available.

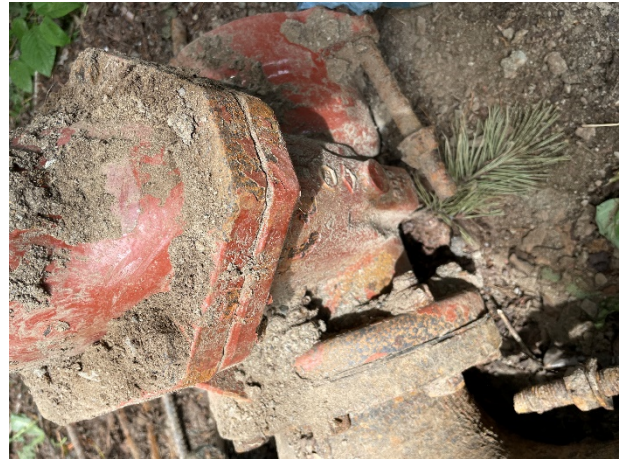
Photo 2 – Minor Surface Corrosion Hydrant Valve W1-18

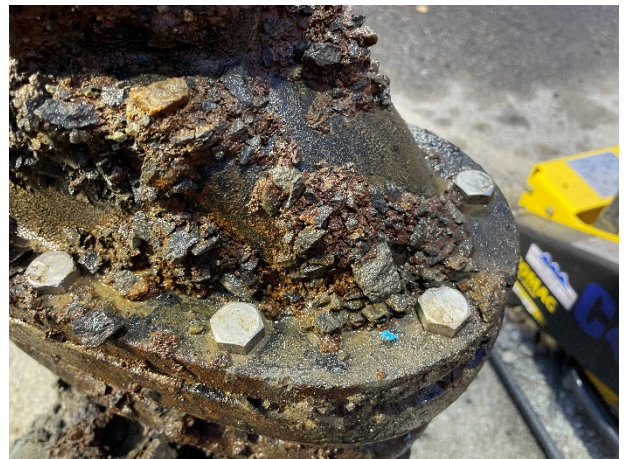
Upon completion of all water valve and fitting replacements, it can be confirmed that corrosive degradation of valves, fittings and restraints was present but not severe. In some cases, encrustation made it difficult to determine the severity of degradation. Bonnet bolts on all valves were in good condition with no observed corrosive degradation.

Photo 4 – W1-D Valve Bonnet Bolts
