**Meadow Park Sports Centre**  
**Wall and Window Condition Assessment**

8625 Highway 99,  
Whistler, BC V0N 1B8

July 28, 2015  
RJC No.: VAN.020011.0009

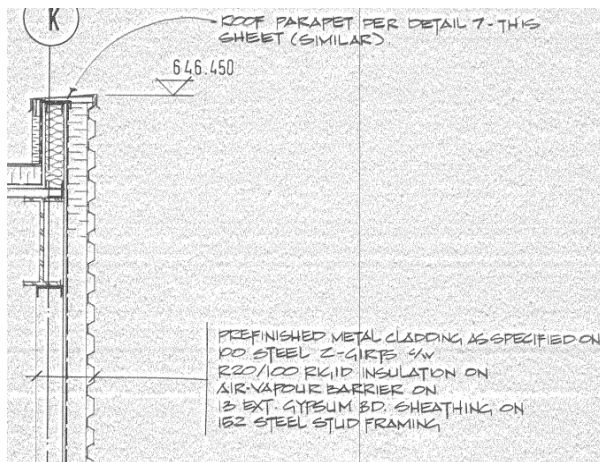
**Wall Type 3 (W3) - Metal Cladding on Steel Stud Frame**

1. This wall assembly was observed along a portion of the pool south elevation and around the 2<sup>nd</sup> floor of the Fitness Centre, including the 1998 renovation.
2. This wall assembly was also observed along the pool's high parapet walls. The steel studs were cleaned and treated and infilled with spray foam to provide a continuous seal at the roof level during the roof replacement project in 2014.
3. Only one interior exploratory recess was completed at the Fitness Centre wall assembly and the wall cavity was clean and dry at the time of review.

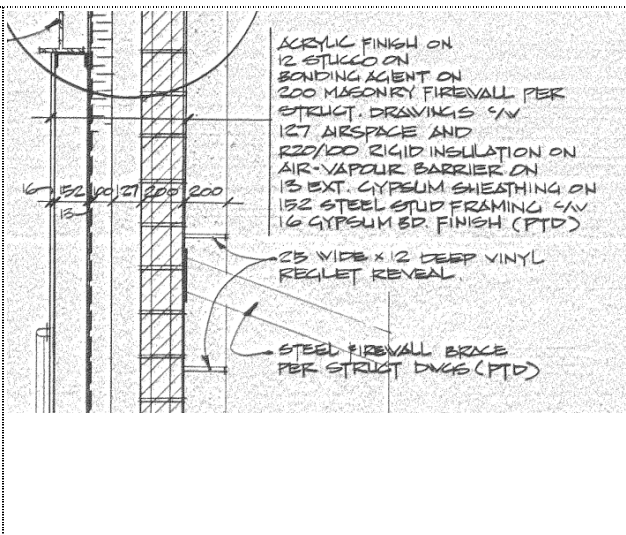
<b>Wall Type 4 (W4) - Stucco Finish on Concrete Block Firewall</b>	
<p>Exterior</p> <ul style="list-style-type: none"> <li>12mm Stucco Finish</li> <li>200mm Concrete Masonry Firewall</li> <li>127mm Air Cavity</li> <li>100mm Rigid Insulation</li> <li>Self-Adhered Membrane</li> <li>13mm Exterior Gypsum Board</li> <li>152mm Steel Stud Framing</li> <li>16mm Interior Gypsum Board</li> </ul> <p>Interior</p> <p>General Notes</p> <ol style="list-style-type: none"> <li>1. This wall assembly was observed along the north elevation of the Fitness Centre adjacent to the Administration roof.</li> <li>2. Note that an exploratory recess was not conducted into this assembly.</li> </ol>

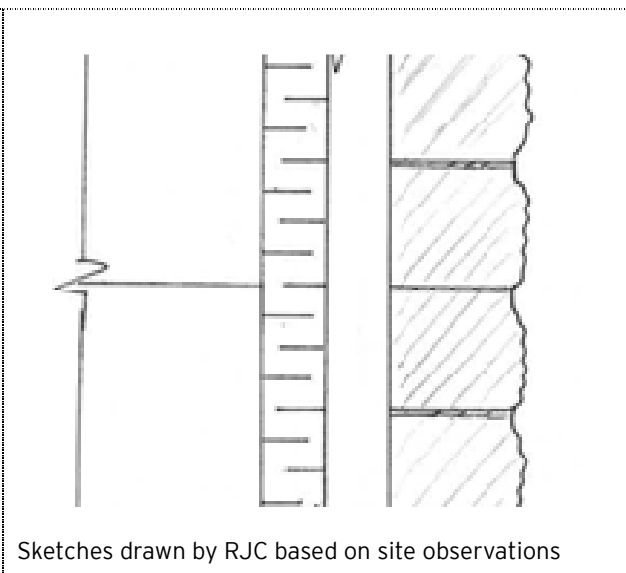
<b>Wall Type 5 (W5)- Masonry Veneer on the Concrete Block Structure</b>	
<p>Exterior</p> <ul style="list-style-type: none"> <li>100mm Masonry Veneer</li> <li>50mm Air Cavity</li> <li>50 mm Rigid Insulation</li> <li>Reinforced Concrete Block</li> </ul> <p>Interior</p> <p>General Notes</p> <ol style="list-style-type: none"> <li>1. This wall assembly was observed along the north and west elevation of the Ice Arena at the ground floor.</li> <li>2. See Wall Type 6 below for the other wall assembly along the Ice Arena.</li> <li>3. A moisture barrier was not observed in the wall assembly.</li> <li>4. Existing architectural drawings of the Ice Arena were not available for review.</li> </ol>

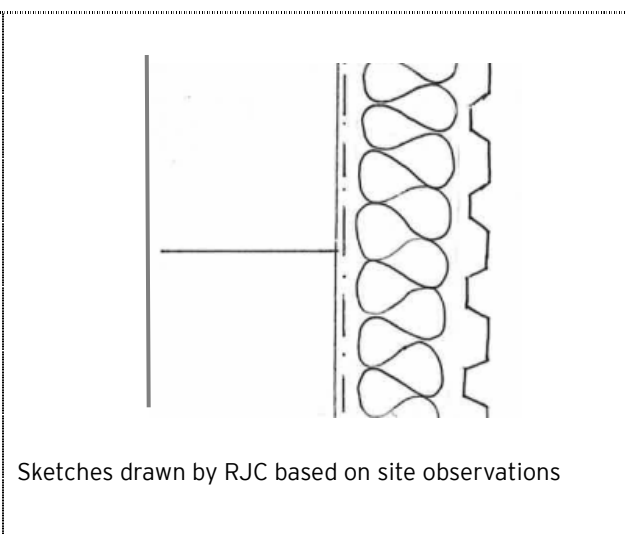
<b>Wall Type 6 (W6) - Metal Cladding on Concrete Block Structure</b>	
<p>Exterior</p> <ul style="list-style-type: none"> <li>Corrugated Metal Cladding attached with non-thermally broken z-girts</li> <li>100mm Fibreglass Batt Insulation</li> <li>Polyethylene Vapour Barrier</li> <li>Reinforced Concrete/Concrete Block</li> </ul> <p>Interior</p> <p>General Notes</p> <ol style="list-style-type: none"> <li>1. This wall assembly was observed along the upper level of the Ice Arena.</li> <li>2. The vapour barrier is not sealed around wall penetrations and window frames.</li> </ol>

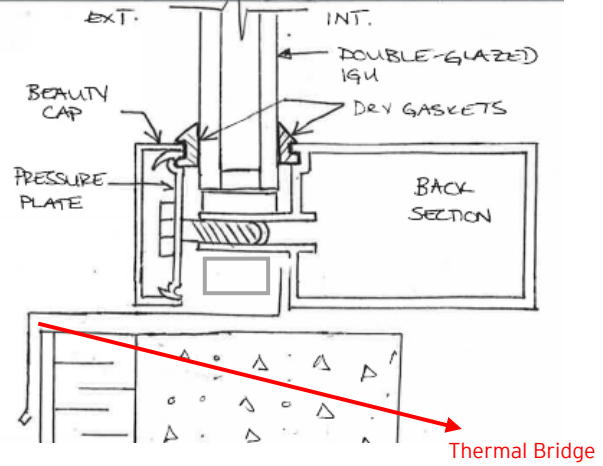
Typically, it would be good practice to extend the wall membrane into the window opening to create a continuous seal. Also, an anti-rotation block should be installed underneath the fastened pressure plate. These typical details were not observed.

Note that the location of the frame within the wall assembly causes thermal bridging, which increases the potential for condensation.

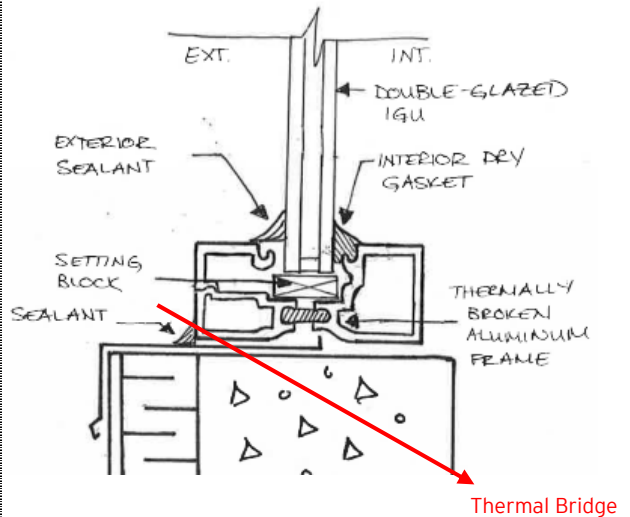
**Window Type 2 (WD2) - Double-Glazed, Thermally-Broken Storefront System**

Dry gaskets were used on the interior and sealant was used on the exterior. This condition allows the glass to sit against the aluminum frame, which could cause the glass to break. Typically, This window system implements dry gaskets on both sides of the insulated glass unit (IGU).

Typically, it is good practice to extend the wall membrane into the window opening and up and over an aluminum angle installed on the interior side of the window frame. Note that the location of the frame within the wall assembly causes thermal bridging, which increases the potential for condensation.

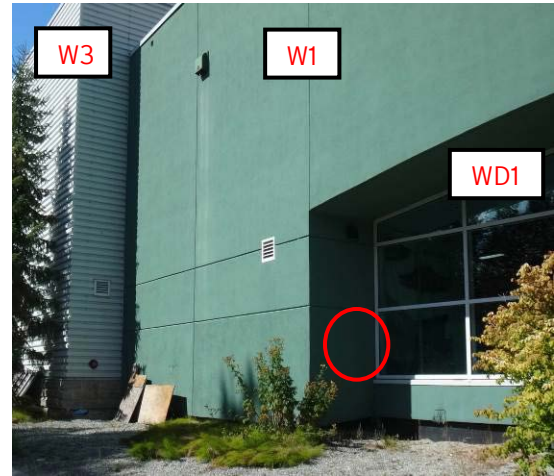
A continuous air vapour barrier was not observed between the window frame and exterior wall assembly, allowing water and air to enter the assembly. The window system is sheltered by an overhang. Corroded fasteners were observed along the pressure plates of the curtain wall window system. Refer to Appendix A for a description of Window Type 1.

Photo A1-1 South Elevation Adjacent to Curtain Wall Windows

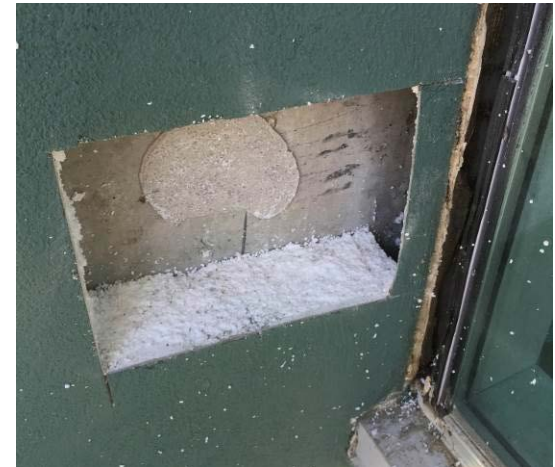
Photo A1-2 Pool - Exploratory Recess No.1

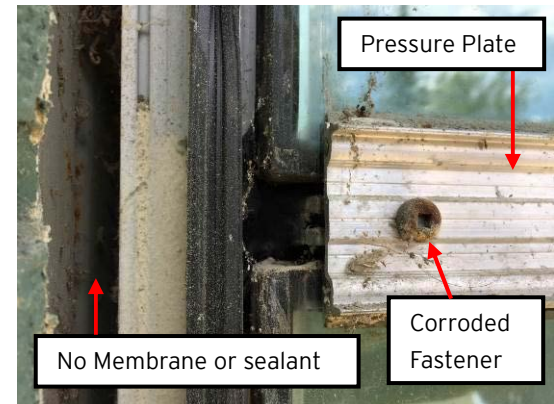
Photo A1-3 Pool - Curtain Wall System - Jamb

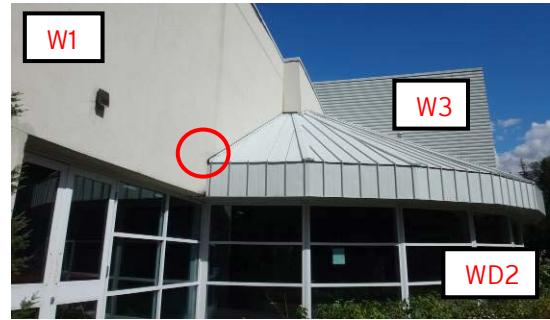
Photo A1-4 Connection between Standing Seam Metal Roof and South Wall of Pool

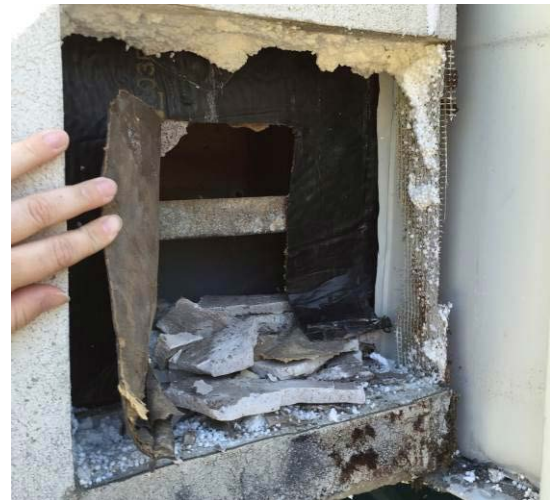
Photo A1-5 Pool - Exploratory Recess No.2

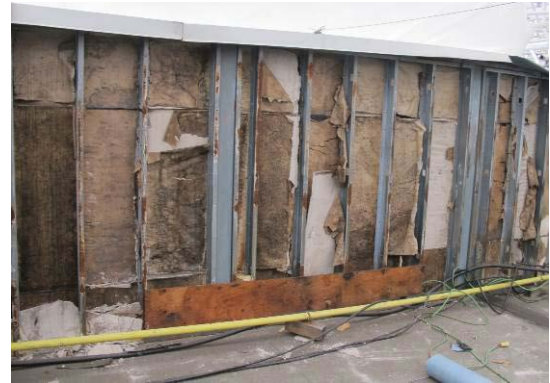
Photo A1-6 Pool Parapet - Deterioration

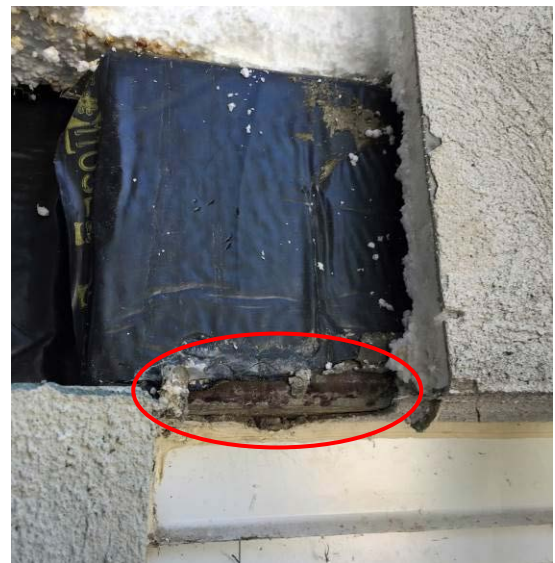
Photo A1-8 Exploratory Recess No.3

The air vapour barrier membrane along the exterior wall is not continuous. The wall membrane terminates at the base of the wall overtop of the steel beam and does not transition into the window opening. The sealant between the EIFS and masonry veneer was deteriorated and cracked, allowing water to enter the wall assembly. Surface corrosion was observed on the metal angle above the window.

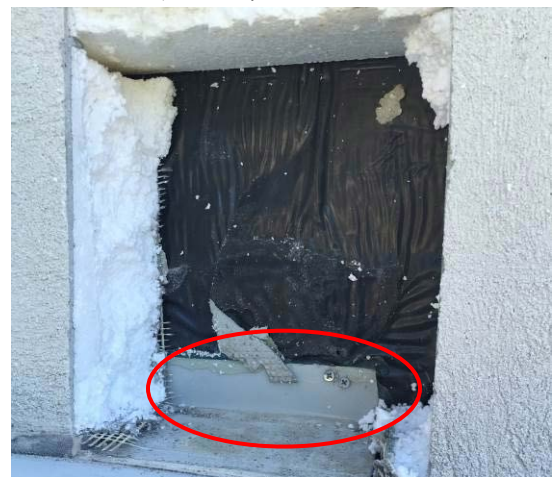
Photo A1-9 Exploratory Recess No.4

The wall membrane does not overlap the saddle flashing and unsealed fasteners were puncturing the membrane. The leg of the saddle extends up the wall 50mm. Typically, it is good practice to fasten materials a minimum of 200mm above the horizontal surface and to extend the wall membrane over transition flashings to provide a continuous seal.

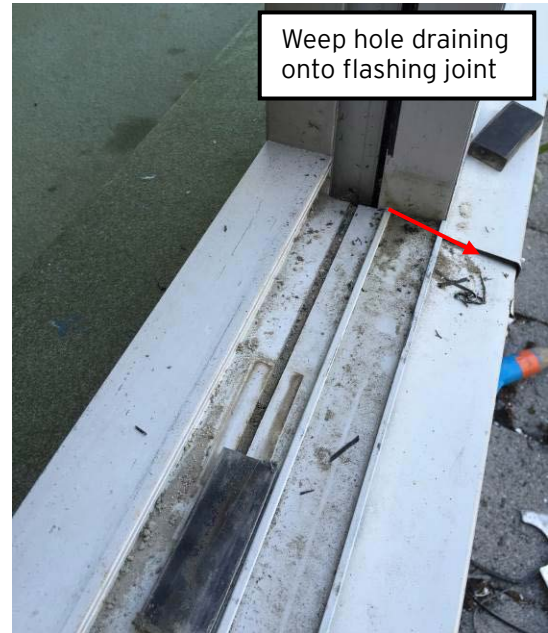
Photo A1-10 Pool Window - West Elevation  
Exploratory Recess No.5

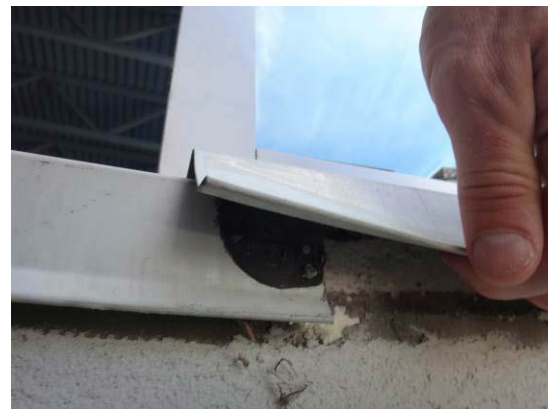
Photo A1-11 Pool Window - Exploratory Recess No.5

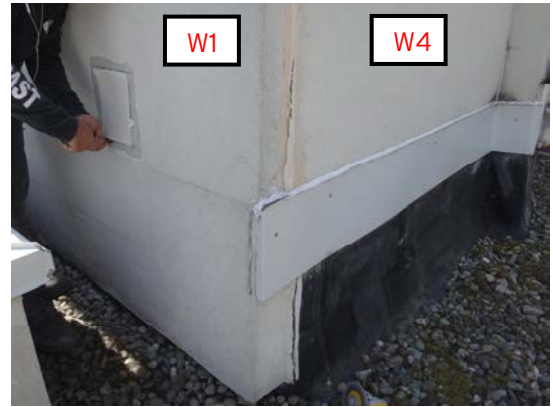
Photo A1-12 Fitness Centre - Northeast Corner - Exploratory Recess No.6

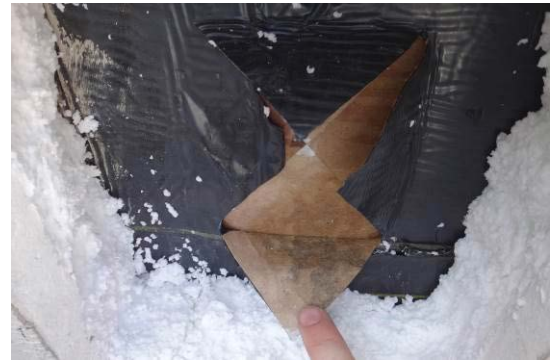
Photo A1-13 Fitness Centre - Northeast Corner - Exploratory Recess No.6

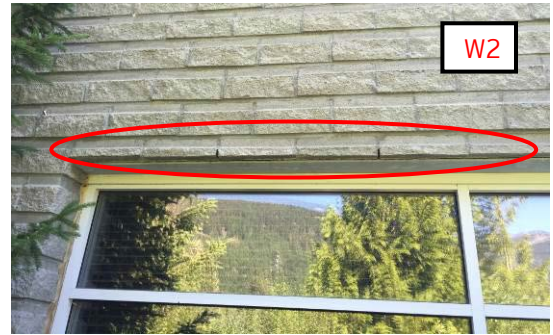
The cavity in the exterior Fitness Centre wall along the ground floor of the west elevation appeared to be clean and dry at the time of review.

Photo A1-14 Fitness Centre - West Elevation

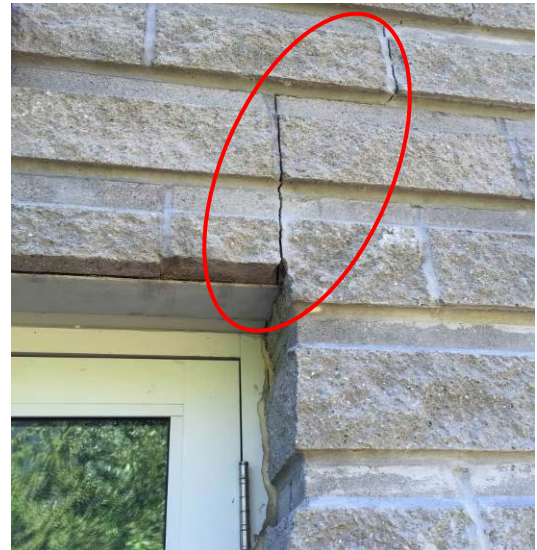
Photo A1-15 Fitness Centre - West Elevation

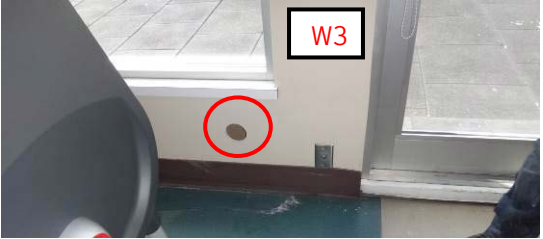
<b>Table B - Meadow Park Sports Centre - Exploratory Recesses Summary</b>	
<b>Wall Type 3 (W3) - Fitness Center Wall Assembly - 1998 Renovation</b>	
<p><u>Exploratory Recess No.8</u></p> <p>The cavity in the exterior Fitness Centre wall along the second floor of the west elevation appeared to be clean and dry at the time of review.</p>	<p>Photo A1-17 Fitness Centre - Exploratory Recess No.8</p>

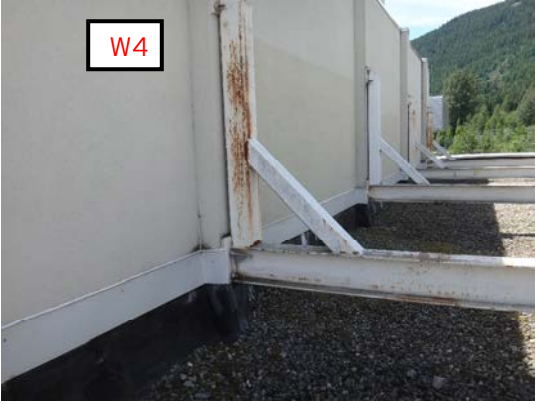
<b>Wall Type 4 (W4) - Fitness Center Wall Assembly</b>	
<p>No recess was completed into Wall Type 4. Refer to Appendix A for the wall assembly and Appendix C for general observations along this wall.</p>	<p>Photo A1-19 Fitness Centre - Northeast Corner</p>

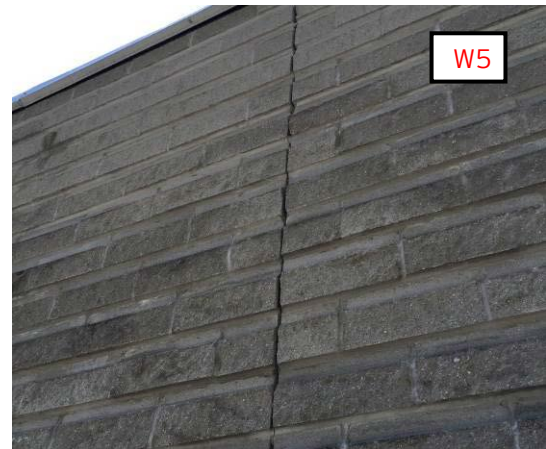
The borescope was used to determine the composition and condition of the exterior wall assembly through the unsealed control joint. Note that no air vapour barrier membrane was observed on the concrete wall structure. Maintenance staff did not mention water ingress issues along the exterior walls of the Ice Arena.

Photo A1-20 Ice Arena - Unsealed Control Joints

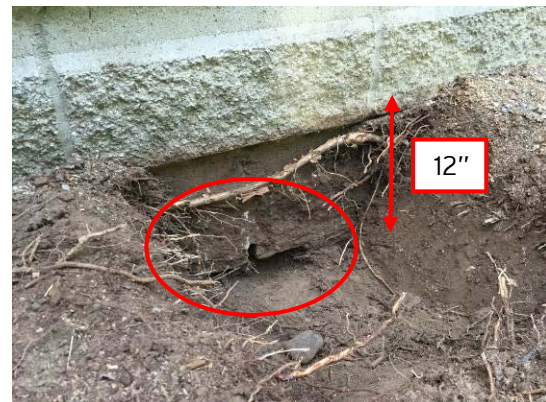
Photo A1-22 Ice Arena - Exploratory Recess No.10

Soft landscaping was removed along the base of the Ice Arena wall along the north elevation. Both the landscaping and pavement are installed approximately 12" above the weep holes in the masonry veneer, which restricts drainage of the wall assembly.

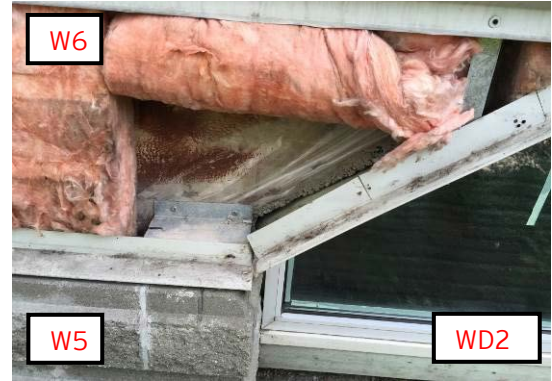
Photo A1-23 Ice Arena - East Elevation - Exploratory Recess No.11 - Exterior

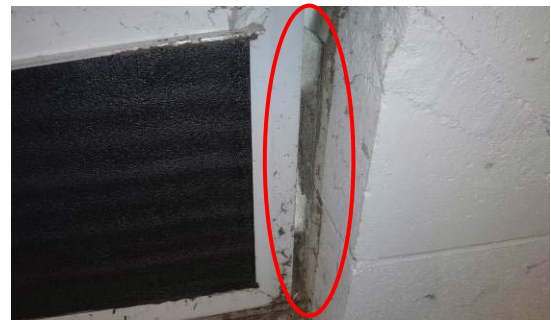
Photo A1-24 Ice Arena - East Elevation - Exploratory Recess No.11 - Interior

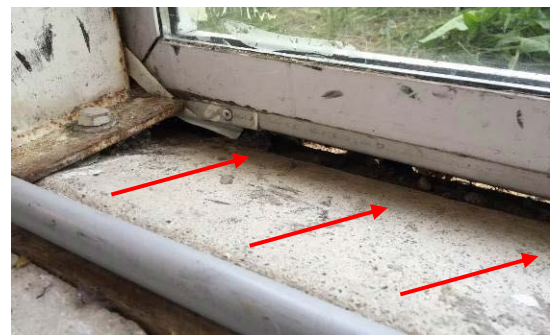
Note that the concrete curb under the window system appeared to have settled and rotated. An air gap was observed under the window frame. The connection between the steel structural and concrete substrate varied from wedge anchors to bolt inserts cast into the concrete. The base of the window appeared to be supported by a metal strap riveted to the frame.

Photo A1-25 Ice Arena - Concrete Curb Deflection

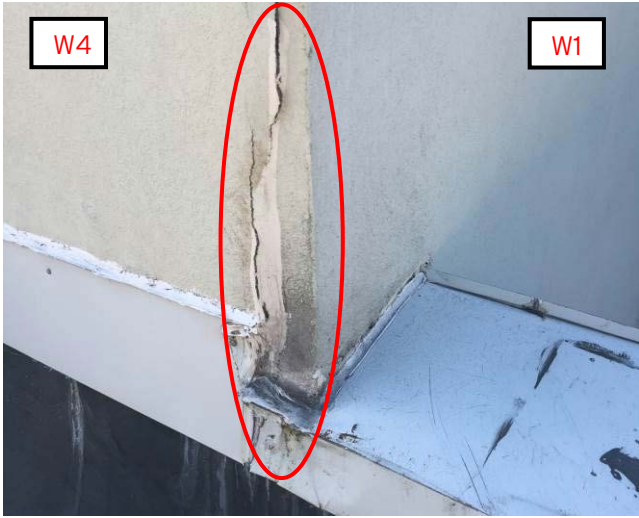
<b>Table C - General Observations</b>	
<p>Location: Fitness Centre - North Elevation - 2-Level</p> <p>Reference: Multiple cracks were observed around the building, which had been previously repaired with sealant. The sealant was deteriorated and failed in multiple locations.</p> <p>Two different wall assemblies (W1 &amp; W4) intersected at this location. No control joint was observed along the transition to allow for movement between the two walls, causing the exterior finish to crack. Similar observations can be seen in Photo 4 below, which shows the condition at the ground level between the two different wall assemblies.</p>

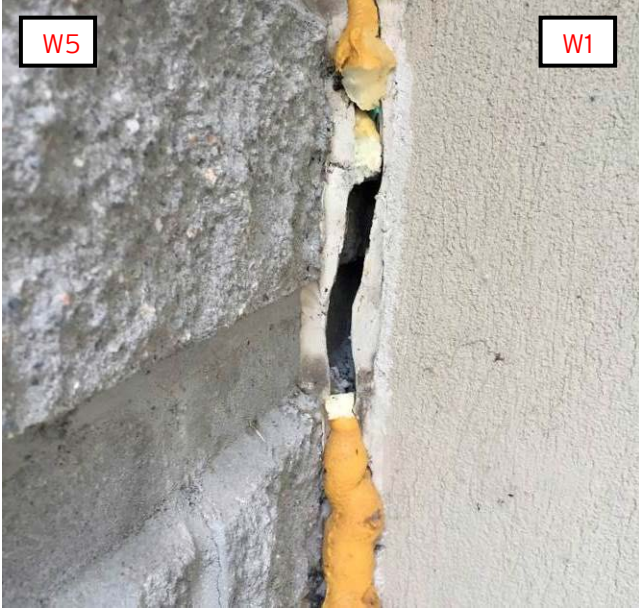
<p>Photo 4</p>

<p>Photo 3</p>
<p>Location: Fitness Centre - Administration Building Transition - Ground Level</p> <p>Reference: The sealants had previously failed and polyurethane foam sealant was then used to fill the void.</p>

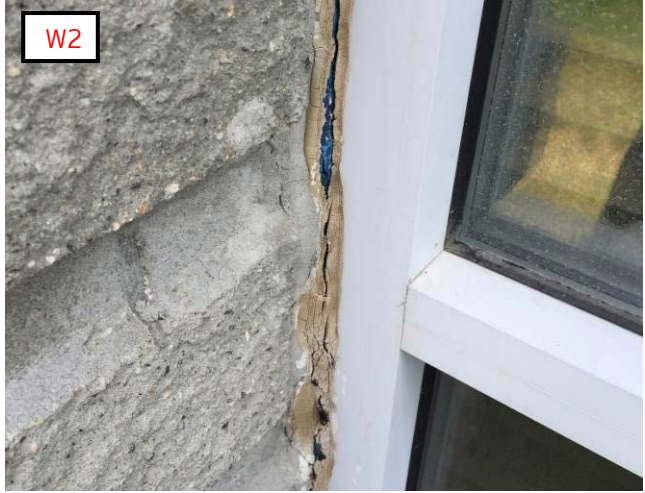
<b>Table C - General Observations</b>	
<p>Location: Fitness Centre - West Elevation</p> <p>Reference: Photo 5 shows the typical condition of the sealant around the window frame perimeters. The sealant was deteriorated and had failed in multiple areas.</p>

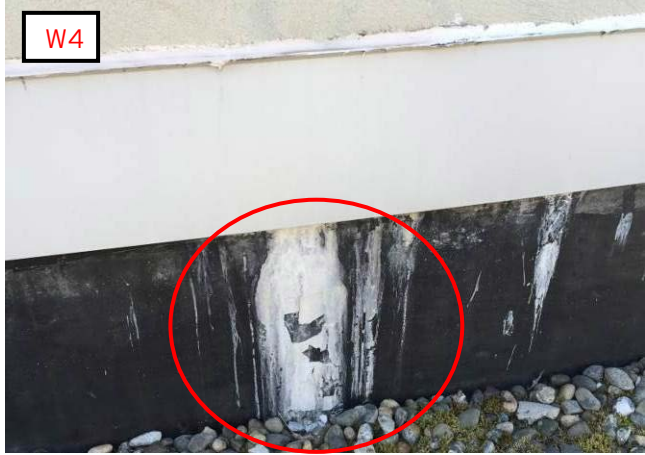
<p>Photo 5</p>
<p>Location: Fitness Centre - North Elevation</p> <p>Reference: Efflorescence was observed at the base of the Fitness Centre wall and onto the Administration roof area. Efflorescence is caused when water evaporates, leaving a salt residue. This suggests the presence of water within the wall assembly (W4).</p> <p>Note that bitumen self-adhered membrane was lapped onto the EPDM roof membrane at this location. These two products are chemically incompatible and the EPDM has become brittle as a result.</p>

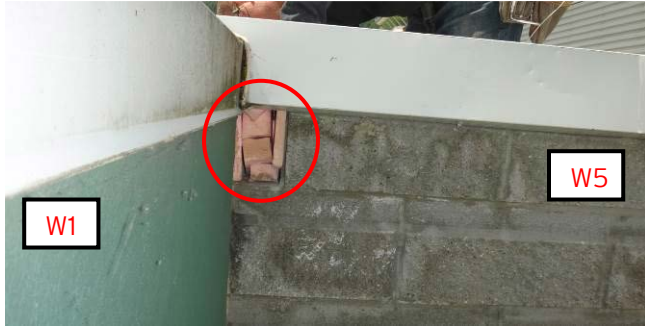
<p>Photo 7</p>

<p>Photo 6</p>
<p>Location: Administration Building - Front Entrance</p> <p>Reference: A concrete masonry unit was missing at the top of the ground floor wall at the building's front entrance. The hole had been stuffed with extra pieces of insulation, allowing water to enter the wall assembly.</p>

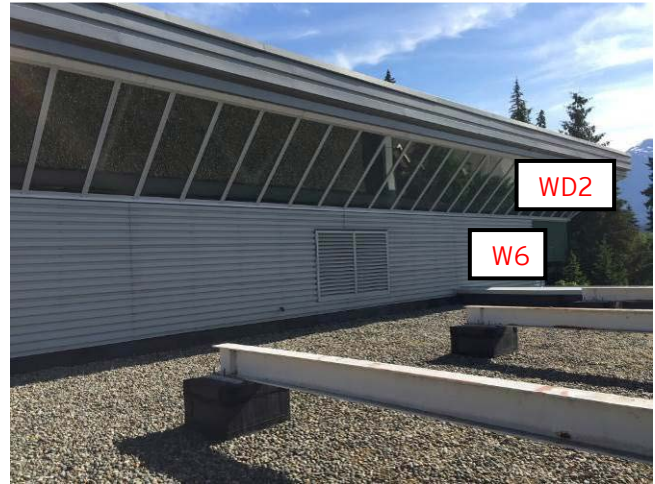
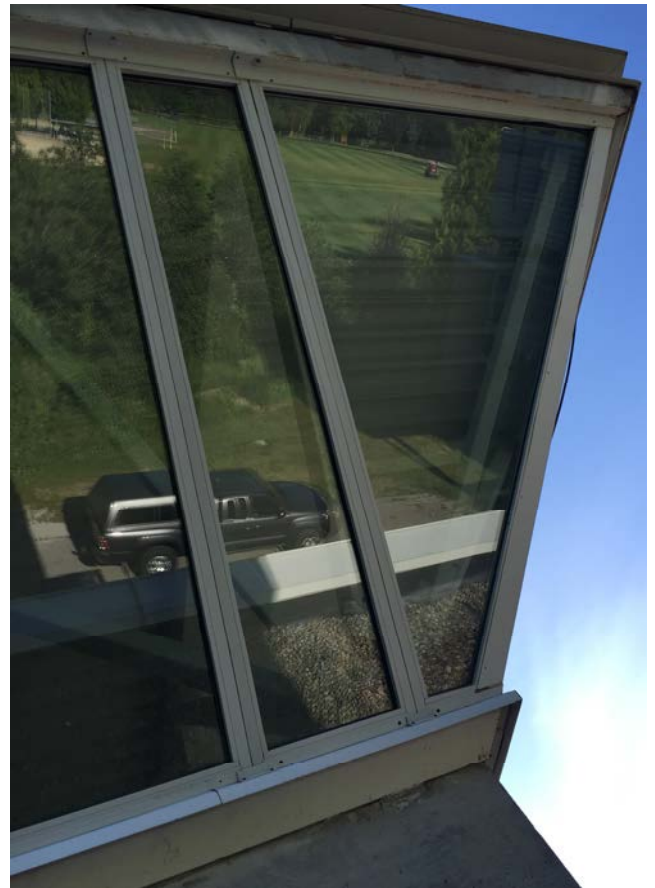
Photo 8 and 9 shows the general configuration of the upper level of the Ice Arena, with perimeter windows and metal cladding over the concrete structure.

Note that the metal cladding was not removed in this location. Refer to exploratory recess No.11 for the typical wall assembly.

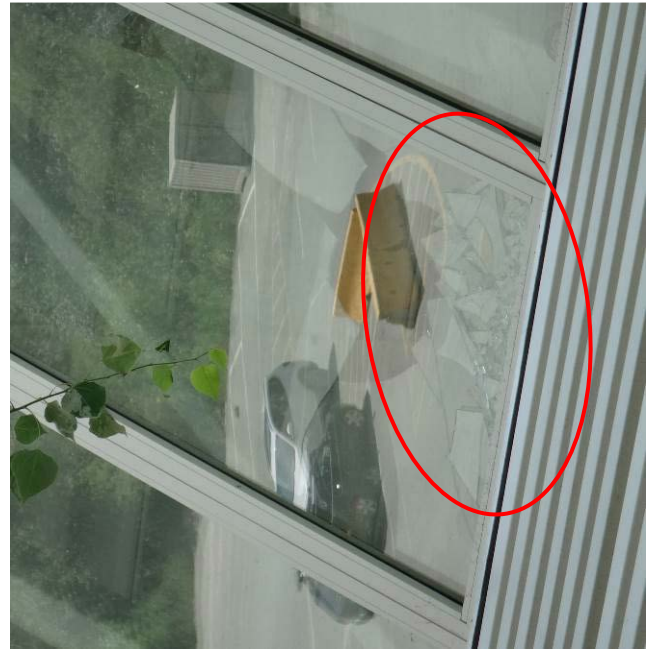
Photo 10

A damaged inner pane of glass was observed along the canopy windows along the east elevation of the Ice Arena.

Note that the type of glazing was not confirmed; however, it is required that the outer pane be laminated where it extends over public space.

A structural assessment of the glazing was outside the scope of this report. It is recommended that a structural review of the existing upper and lower windows at the Ice Arena is conducted to determine the type of glass, structural capacity of the window system and the structural connection to the base building.

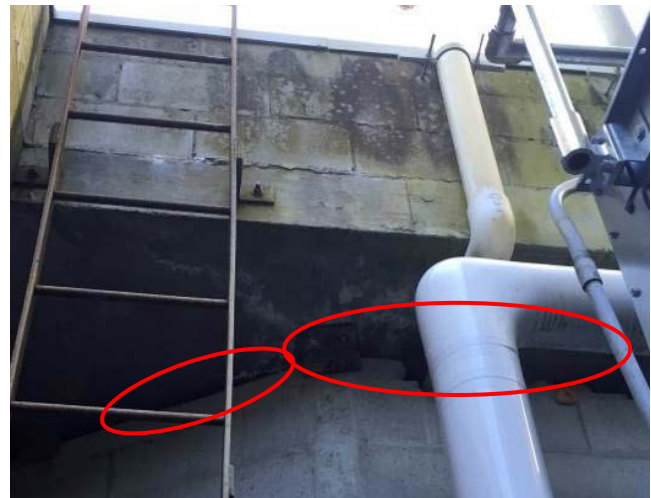
Photo 12

The perimeter concrete block structure at the roof access location is not sealed to the roof structure. There is no drip edge around the parapet of the roof access point, allowing water to enter the wall assembly. Metal clips between the concrete roof slab and the concrete block wall were observed.

Efflorescence was also observed at this location.

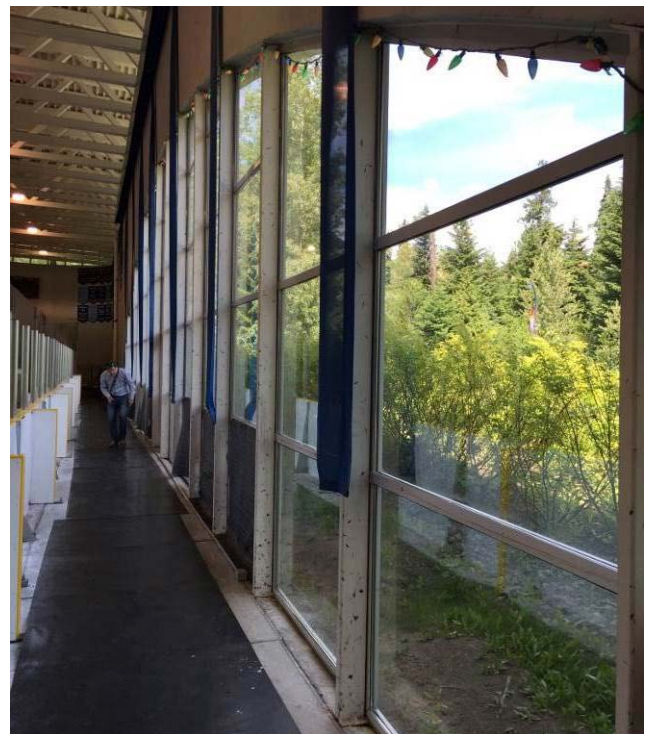
Photo 13

The storefront windows along the east elevation of the Ice Arena sit on the concrete curb below.

See photos below for close-up of window system.

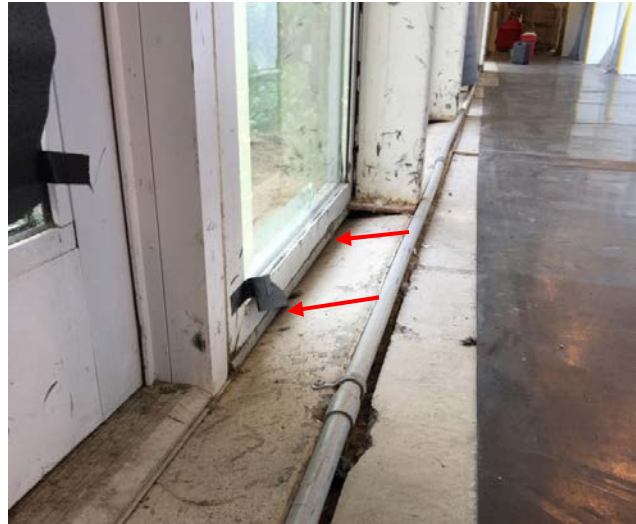
Photo 14

The concrete curb below the window appeared to have settled and rotated outward.

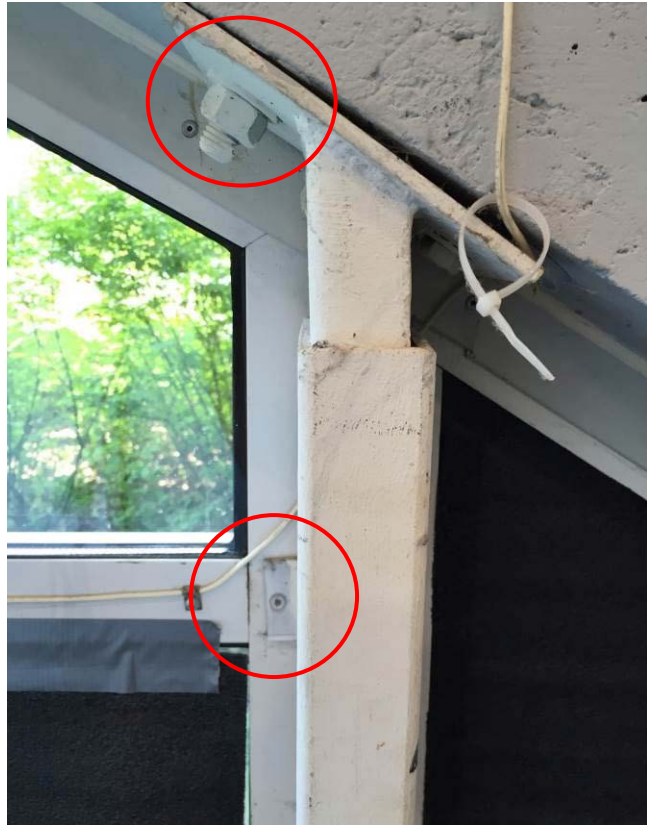
Photo 15

The window system was fastened to the steel columns with clips. The steel structure is anchored into the reinforced concrete at the top and bottom.

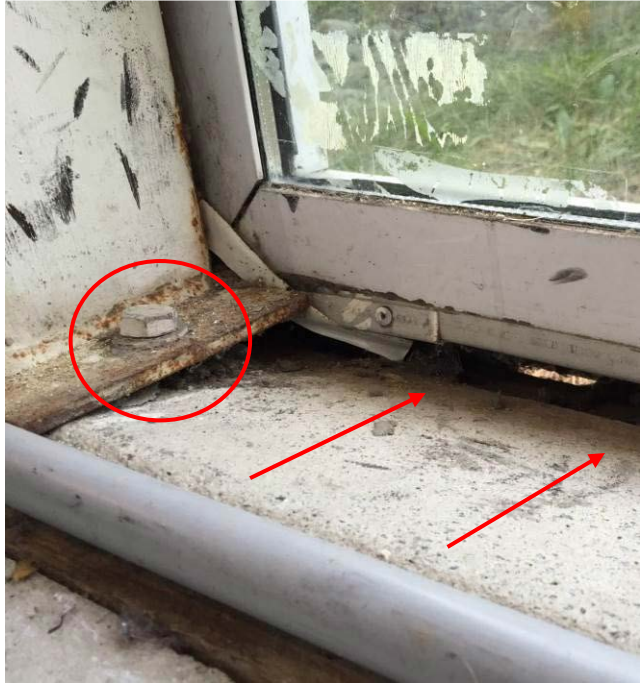
<b>Table C - General Observations</b>	
<p>Location: Ice Arena - East Elevation - Interior</p> <p>Reference: The steel structure was connecting to the concrete slab with a variety of anchors. The window appeared to be supported by a metal strap riveted to the frame.</p>

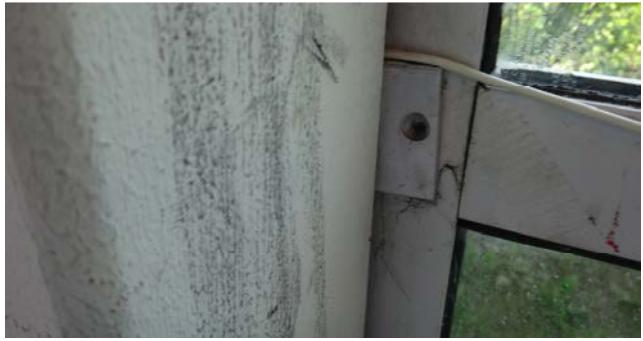
<p>Photo 17</p>

<p>Photo 16</p>
<p>Location: Ice Arena - East Elevation - Interior</p> <p>Reference: The window system is fastened to the steel columns with metal clips. Some of the metal clips observed were missing fasteners.</p>
