January 13, 2025

Our Reference: 32564

Resort Municipality of Whistler
 4325 Blackcomb Way
 Whistler, BC V8E 0X5

Reference: Sewer Valve and Fittings Corrosion – Observations and Recommendations

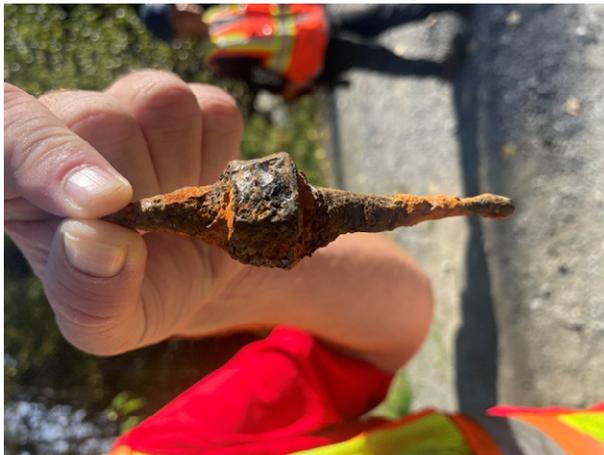
Photo 1 - Corroded Restraining Rod (S2-13 45° Bend)

Upon analysis of our observations, it has become evident that the valve and fitting restraints were the primary target of corrosive degradation. The likelihood of future failures of these in certain instances is significant if left unaddressed.

- Continue with valve and fitting replacement program focusing on areas where there have been recent failures and/or areas where extensive corrosion has been noted during excavation.
- Scheduled replacement will likely be more cost effective and less disruptive in comparison with emergency replacement in the unfortunate case of failure.
- When replacing any iron works, replace it with stainless steel where possible and wrap in Denso as per manufacturers specifications with three-part system.

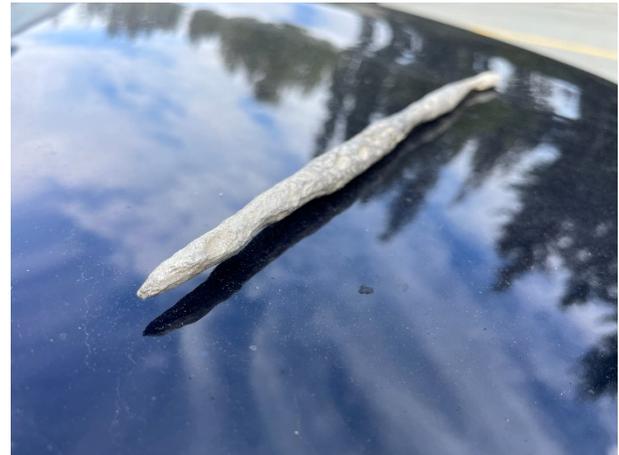
Photo 2 - Corroded Restraining Rod (S2-16 22.5° Bend)

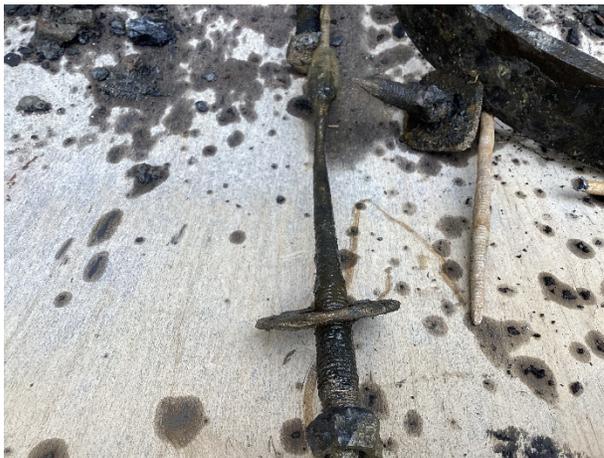
Photo 3 - Corroded Restraining Rod (S2-14 22.5° Bend)

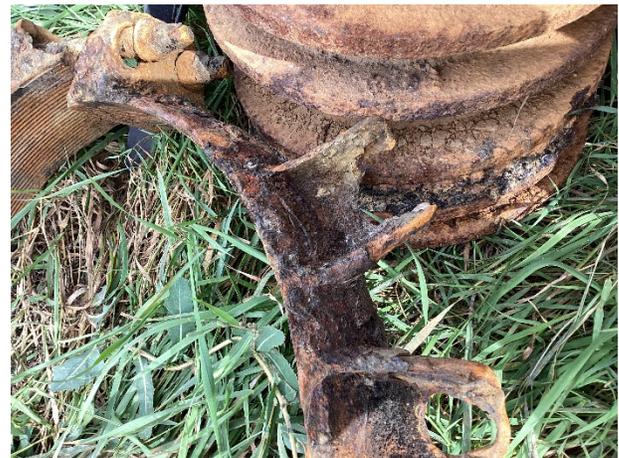
Photo 4 - Corroded Split Ring Restraining Ear (S2-19 22.5° Bend)

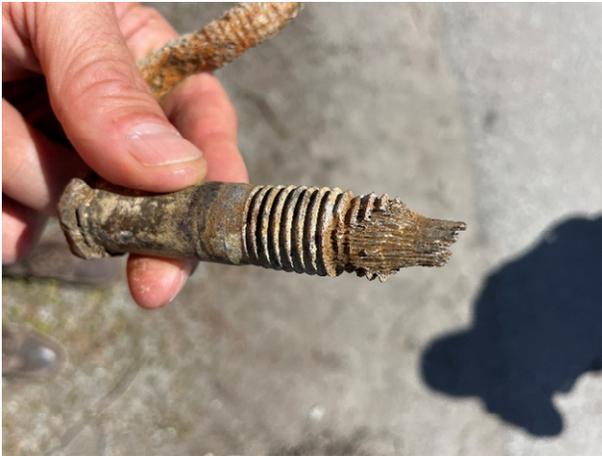
Photo 1 - Corroded Flange Connection Bolt (W4-23 Hydrant Tee)

Upon analysis of our observations, it has become evident that the restraining hardware and valve/fitting flange connection hardware were the primary target of corrosive degradation. The likelihood of future failures of these in certain instances is significant if left unaddressed.

- Continue with valve and fitting replacement program focusing on areas where there have been recent failures and/or areas where extensive corrosion has been noted during excavation.

- Scheduled replacement will likely be more cost effective and less disruptive in comparison with emergency replacement in the unfortunate case of failure.
- When replacing any iron works, replace it with stainless steel where possible and wrap in Denso as per manufacturers specifications with three-part system.

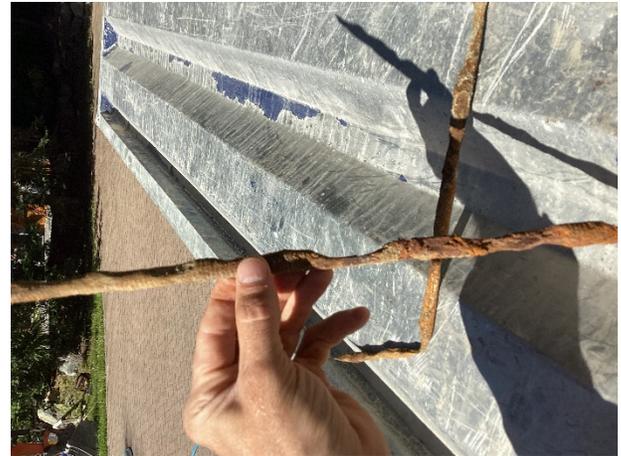
Photo 2 - Corroded Restraining Rod (W4-23 Hydrant Lead)

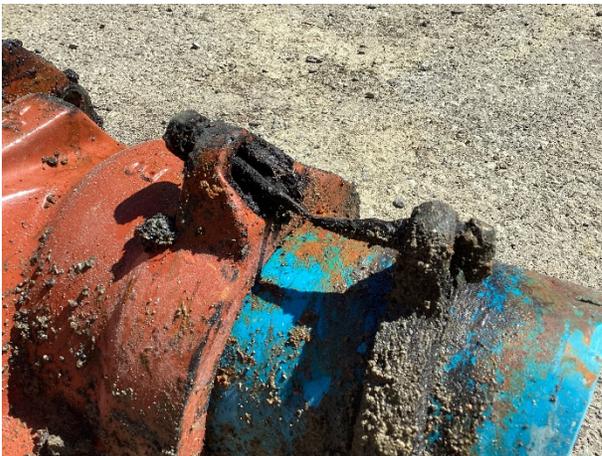
Photo 3 - Corroded Restraining Rod (W4-25 Hydrant Tee)

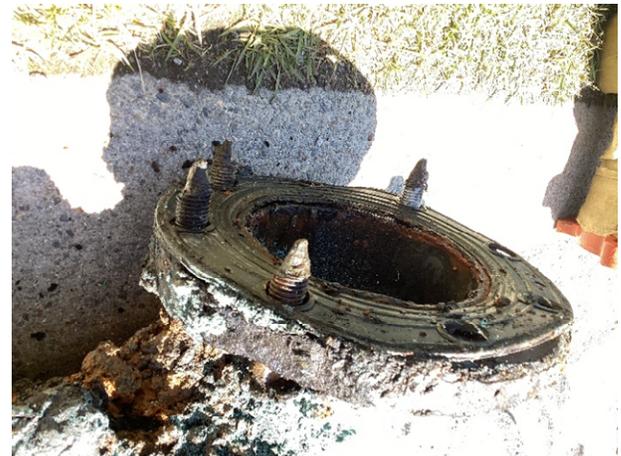
Photo 4 - Corroded Flange Connection Bolts (W4-25 Hydrant Tee)

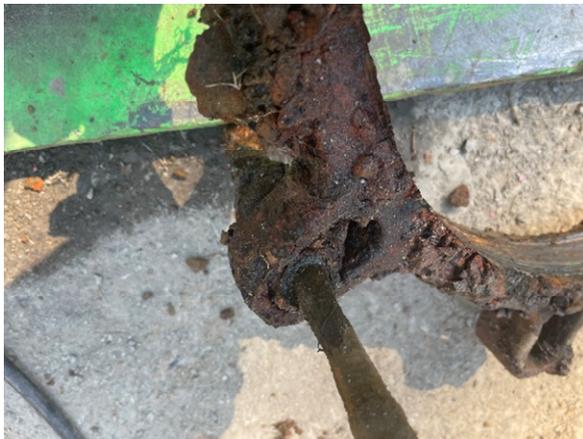
Photo 1 - Corroded Restraining Rod (S1-7 90° Bend)

Upon analysis of our observations, it has become evident that the fitting restraining rods were the primary target of corrosive degradation. The likelihood of future failure of these rods in certain instances is significant if left unaddressed. Fittings themselves and restraining rings appeared to have less severe corrosive degradation.

- Continue with fittings replacement program focusing on areas where there have been recent failures and/or areas that extensive corrosion has been noted during excavation.
- Scheduled replacement will likely be more cost effective and less disruptive in comparison with emergency replacement in the unfortunate case of failure.
- When replacing any iron works wrapping in Denso as per manufacturers specifications with the three-part system is imperative.
- Look into other methods of corrosion control available.

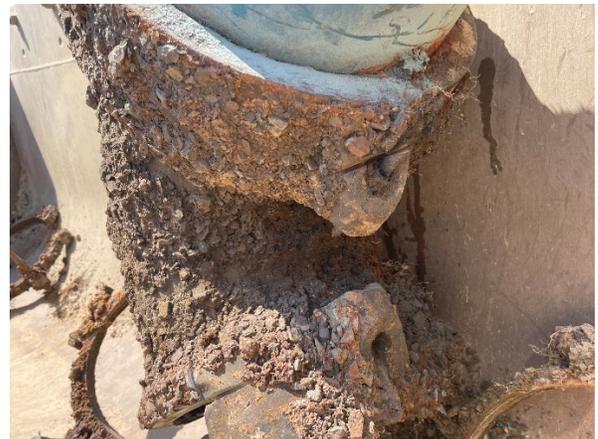
Photo 2 – Encrustation and Surface Corrosion (S1-7 90° Bend)

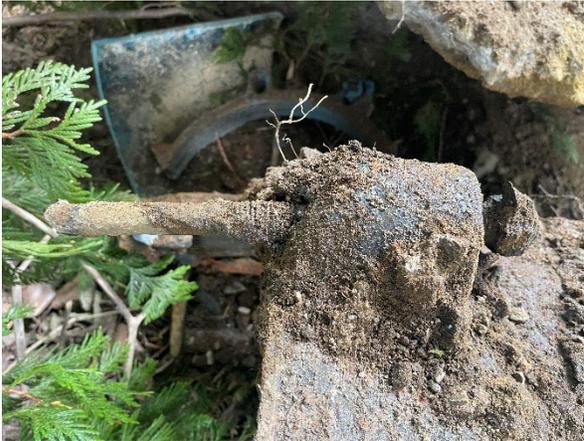
Photo 3 - Corroded Restraining Rod (S1-4 11.25° Bend)

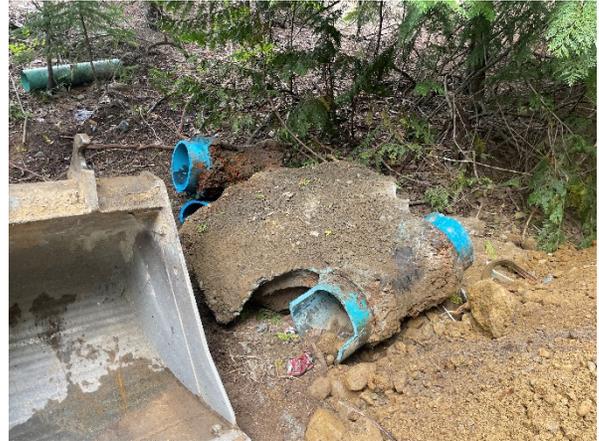
Photo 4 - Encrustation and Surface Corrosion (S1-6 11.25° Bend)

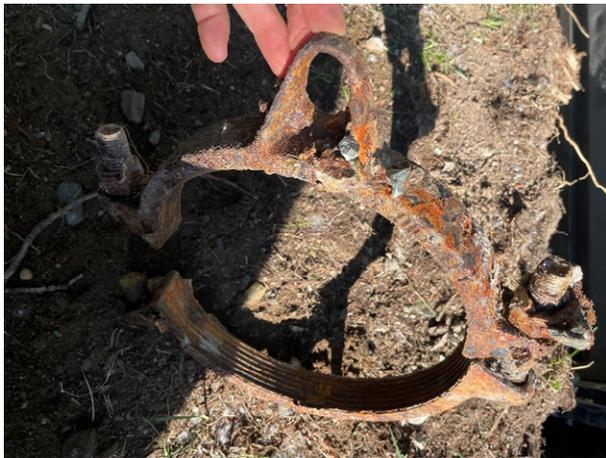
Photo 1 – Minor Surface Corrosion on Restraining Ring W1-17

- Continue with fittings replacement program focusing on areas where there have been recent failures and/or areas that extensive corrosion has been noted during excavation.
- When replacing any iron works wrapping in Denso as per manufacturers specifications with the three-part system is imperative.
- Look into other methods of corrosion control available.

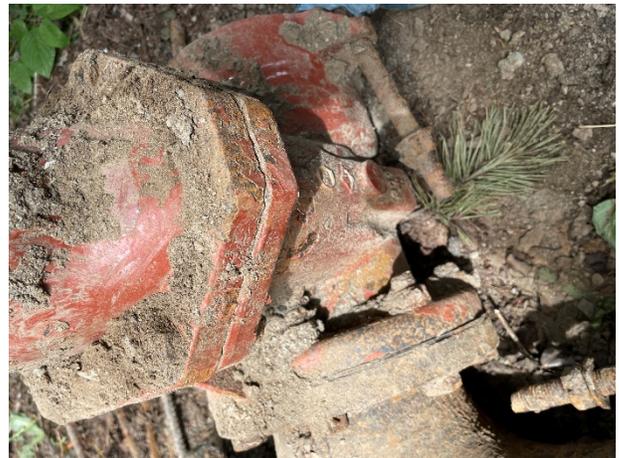
Photo 2 – Minor Surface Corrosion Hydrant Valve W1-18

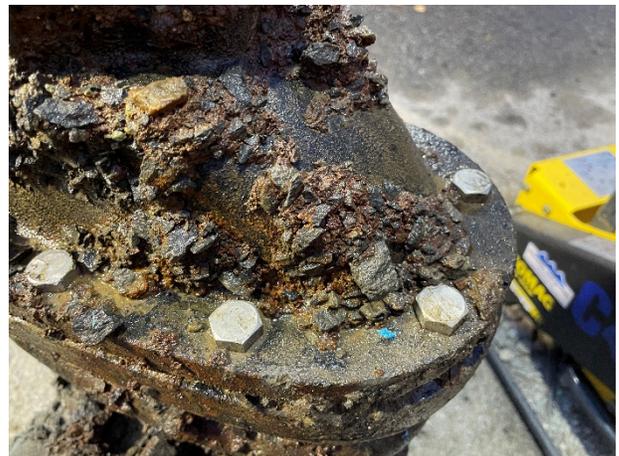
Photo 4 – W1-D Valve Bonnet Bolts

Upon completion of all water valve and fitting replacements, it can be confirmed that corrosive degradation of valves, fittings and restraints was present but not severe. In some cases, encrustation made it difficult to determine the severity of degradation. Bonnet bolts on all valves were in good condition with no observed corrosive degradation.

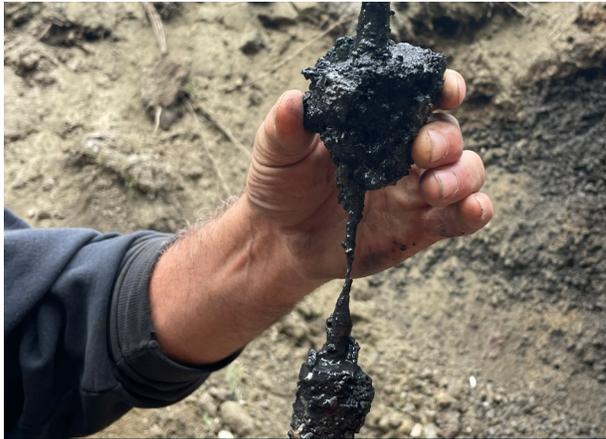
Photo 1 - Corroded Restraining Rod.

After review of our observations and findings it appears that corrosion was the worst in cases where there was heavy groundwater present in the trench. It was also noted that the restraining rings and rods were most subject to corrosive attack. Valves and the fittings themselves complete with hardware appeared to be less affected however corrosion was observed on these items and if left in place future failure of these fittings is considered likely.

- Continue with fittings replacement program focusing on areas where there have been recent failures and/or areas that extensive corrosion has been noted during excavation.
- Scheduled replacement will likely be more cost effective and less disruptive in comparison with emergency replacement in the unfortunate case of failure.
- When replacing any iron works wrapping in Denso as per manufacturers specifications with the three-part system is imperative.
- Look into other methods of corrosion control available.

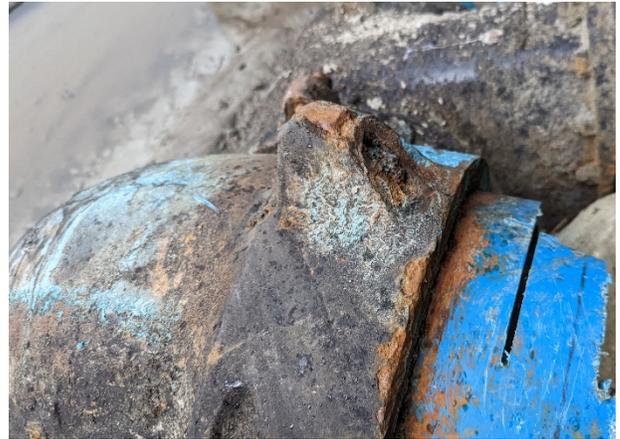
Photo 2 - Corroded 90° Bend Restraining Ear.

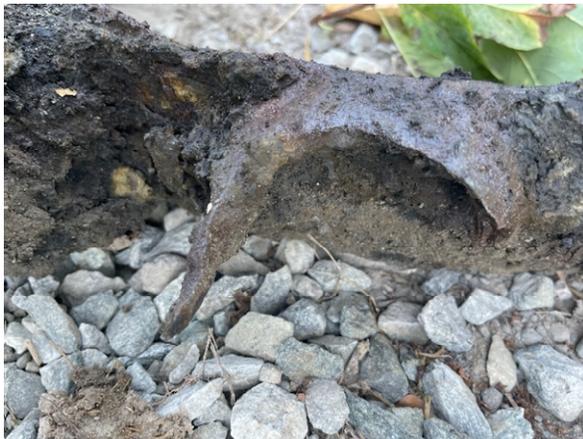
Photo 3 - Corroded Restraining Ring Ear.

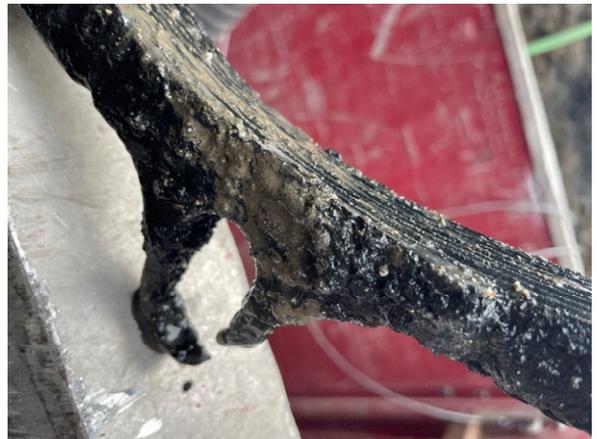
Photo 4 - Corroded Restraining Ring Ear.

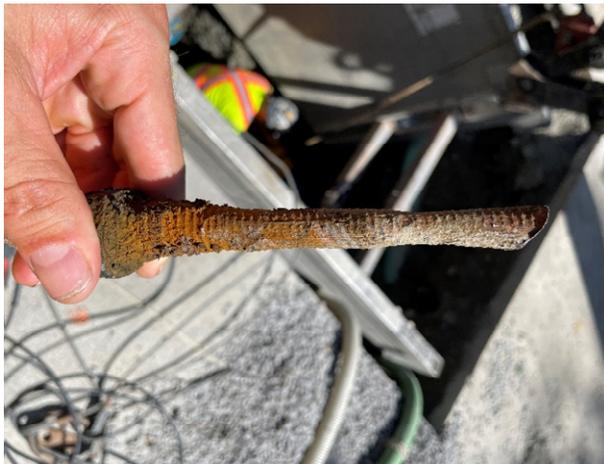
Photo 1 - Corroded Restraining Rod.

After review of our observations/findings it appears that corrosion was the worst in cases where there was heavy groundwater present in the trench. It was also noted that the restraining rings and rods were most subject to corrosive attack. Valves and the fittings themselves complete with hardware appeared to be less affected however corrosion was observed on these items and if left in place future failure of these fittings is considered likely.

- Continue with fittings replacement program focusing on areas where there have been recent failures and/or areas that extensive corrosion has been noted during excavation.
- Scheduled replacement will likely be more cost effective and less disruptive in comparison with emergency replacement in the unfortunate case of failure.
- When replacing any iron works wrapping in Denso as per manufacturers specifications with the three-part system is imperative.
- Look into other methods of corrosion control available.

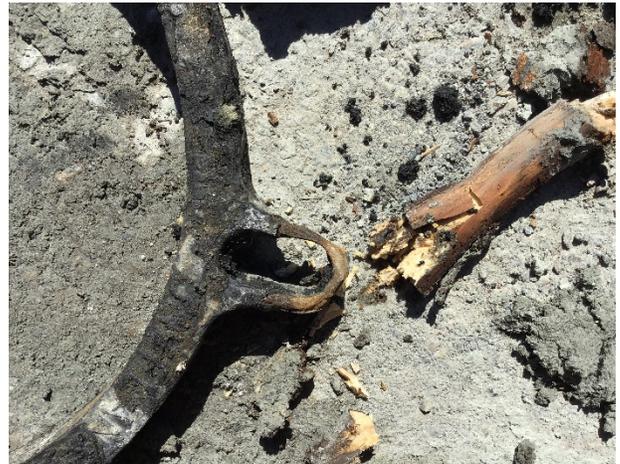
Photo 2 - Corroded Restraining Ring Ear.

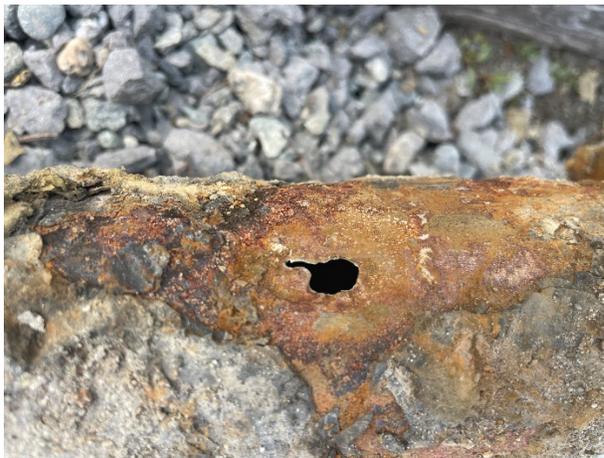
Photo 3 – Blow-off Pipe Corrosion.

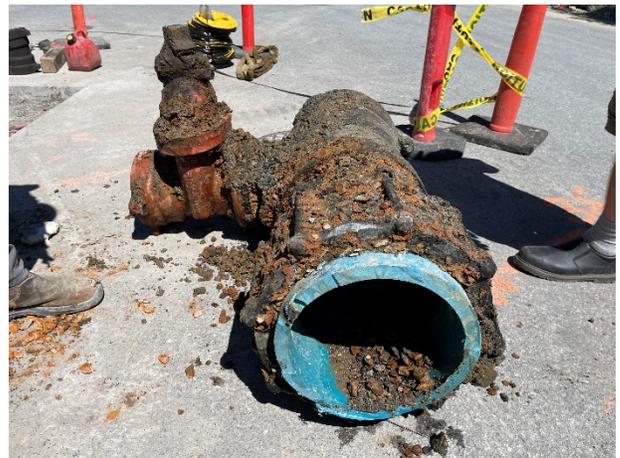
Photo 4 – Valve & Tee Corrosion.
