January 13, 2023

Resort Municipality of Whistler
4325 Blackcomb Way
Whistler, BC V8E 0X5

Reference: Sewer Fixture & Fittings Corrosion – Observations and Recommendations

Reference: Water Fixture & Fittings Corrosion – Observations and Recommendations

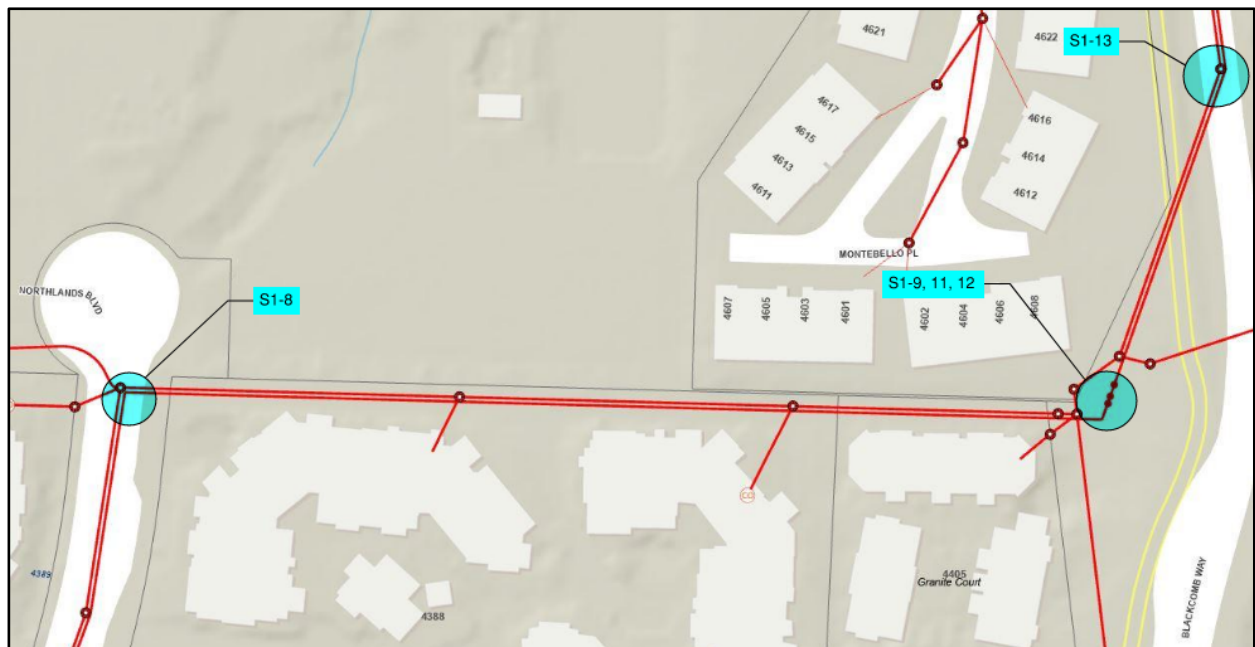
Figure 1 – Project Limits

ISL Engineering and Land Services Ltd. (ISL) was retained by the Resort Municipality of Whistler (RMOW) to provide design, contract and construction management services associated with the valves and fittings replacement project. The construction scope involved replacement of valves and fittings on the sanitary sewer system due to age and suspected corrosive attack. Drake Excavating Ltd. was awarded the contract to perform the work. All replacements were located on Northlands Boulevard & Blackcomb Way North or Lorimer Rd, and on the trail behind 4405 Blackcomb Way.

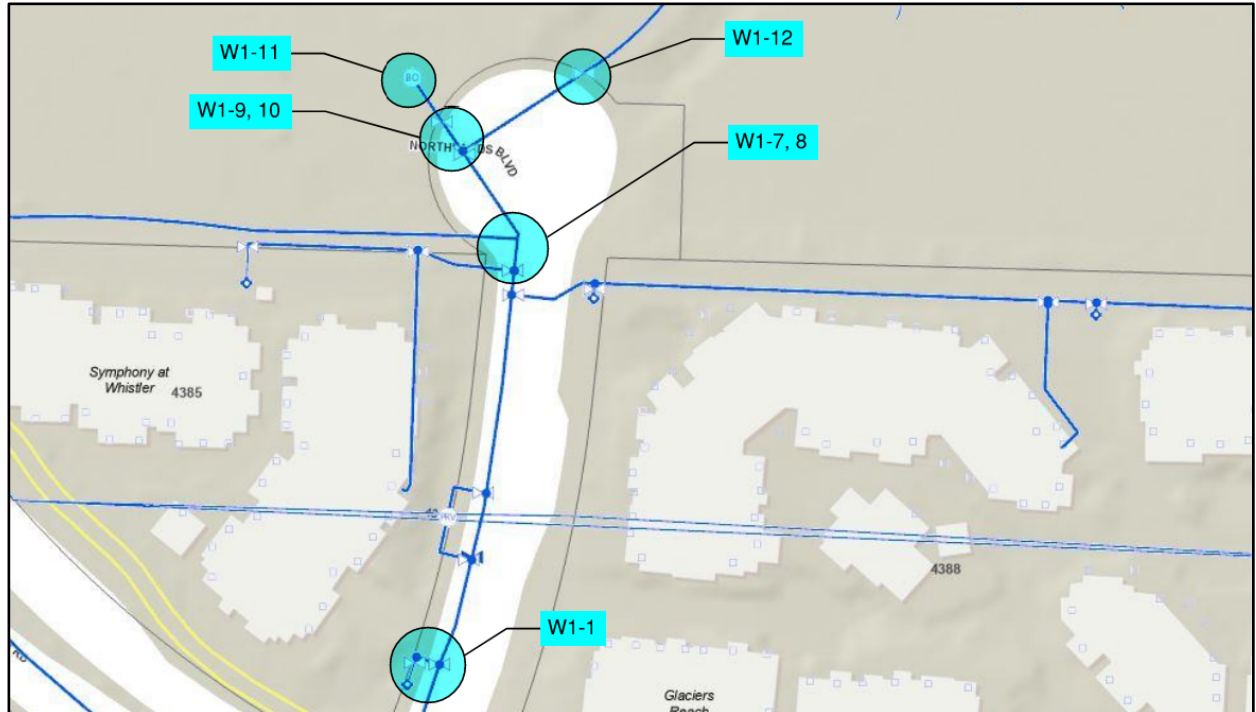
Figure 1 – Project Limits

ISL Engineering and Land Services Ltd. (ISL) was retained by the Resort Municipality of Whistler (RMOW) to provide design, contract and construction management services associated with the valves and fittings replacement project. The construction scope involved replacement of valves and fittings on the water sewer system due to age and suspected corrosive attack. Drake Excavating Ltd. was awarded the contract to perform the work. All replacements were on Northlands Boulevard north of Lorimer Road.

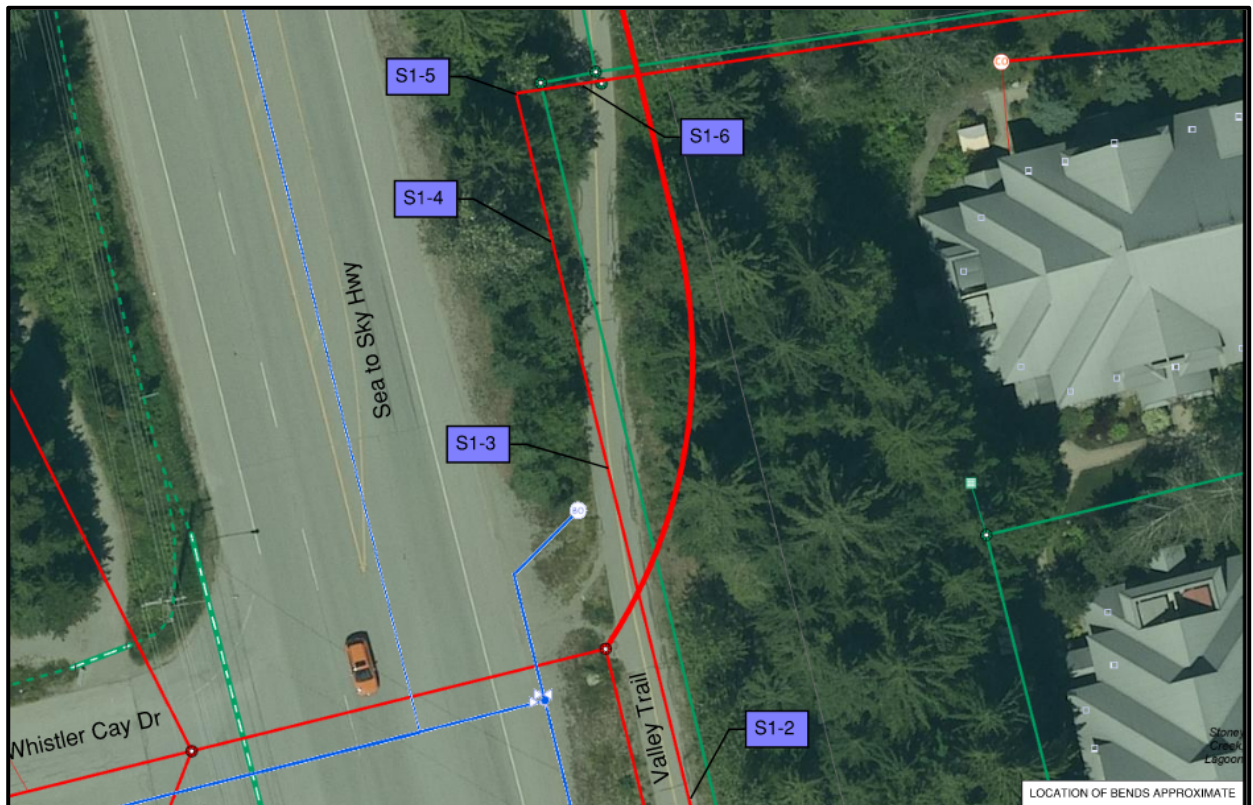
Figure 1 – Project Limits Valley Trail

ISL Engineering and Land Services Ltd. (ISL) was retained by the Resort Municipality of Whistler (RMOW) to provide design, contract and construction management services associated with the 2023 Valves and Fittings Replacement Project. The construction scope involved replacement of fittings on the sanitary sewer system due to age and suspected corrosive attack. Coastal Mountain Excavations Ltd. was awarded the contract to perform the work. All replacements were located on Northlands Boulevard & Valley Trail paralleling Sea to Sky Highway across from Whistler Cay Drive.

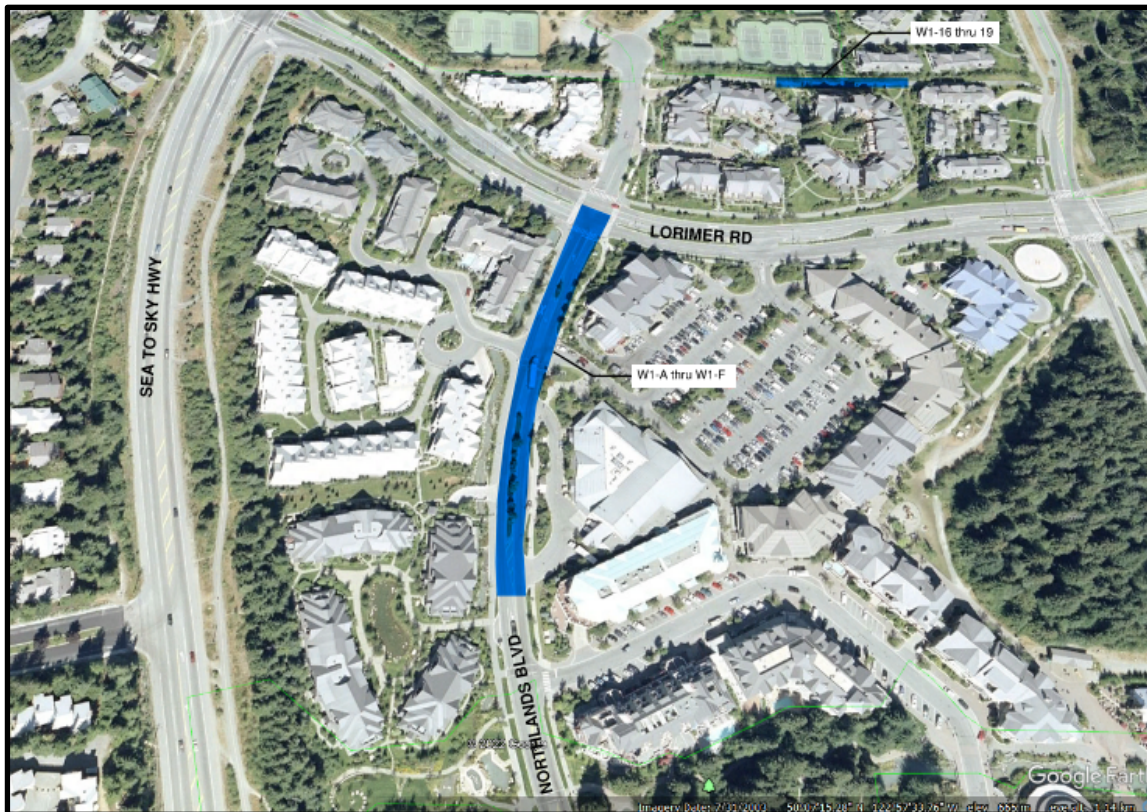
Figure 1 – Project Limits

ISL Engineering and Land Services Ltd. (ISL) was retained by the Resort Municipality of Whistler (RMOW) to provide design, contract and construction management services associated with the 2023 Valves and Fittings Replacement Project. The construction scope involved replacement of valves and fittings on the water system due to age and suspected corrosive attack. Coastal Mountain Excavations Ltd. was awarded the contract to perform the work. All replacements were on Northlands Boulevard and the private trail behind Granite Court Condos (4405 Blackcomb Way).
