**Meadow Park Sports Centre**  
**Wall and Window Condition Assessment**

8625 Highway 99,  
Whistler, BC V0N 1B8

July 28, 2015  
RJC No.: VAN.020011.0009

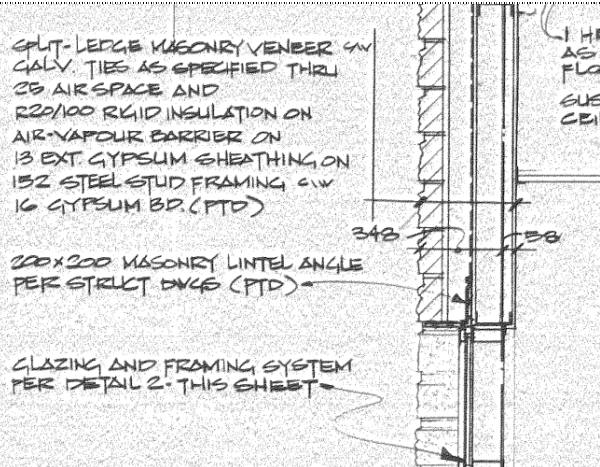
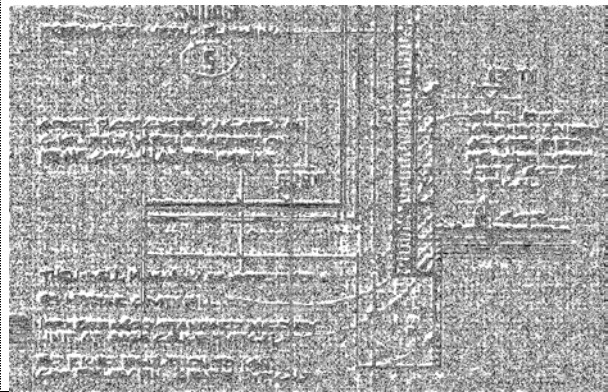
1. This wall assembly was observed along the west elevation at the ground floor of the Fitness Centre.

A similar exterior wall assembly was observed along the east elevation at the ground floor of the Fitness Centre; however, the structure was reinforced concrete (as shown on record drawings).
